Asbestos Management Survey
At
**Joint Valuation Board and Education Resource Centre,
235 Dumbarton Road, Clydebank**

Customer: West Dunbartonshire Council

Project No: G13-00301

Report Issue Date: 14 June 2013

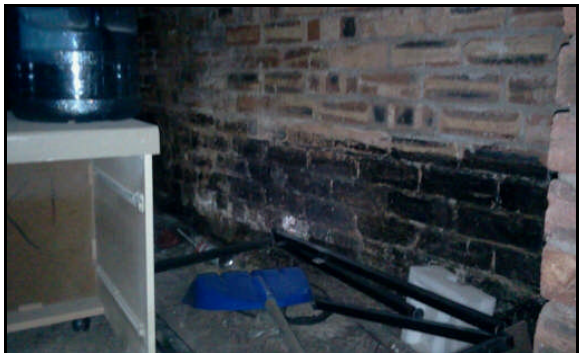
Building ID	Joint Valuation Board & Education Resource Centre	Item Description	Bitumen Damp Proof Course At Base Of Walls
Sample No.	S0002	Material	Bituminous Products
Floor	First Basement Level	Asbestos Type	No Asbestos Detected
Room No.	04	Extent	-
Room ID	Void Area	Notes:

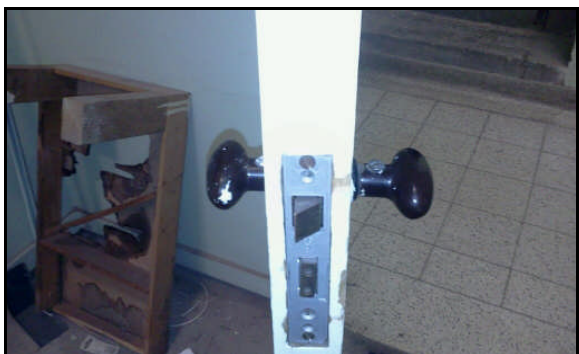
Building ID	Joint Valuation Board & Education Resource Centre	Item Description	Bakelite Door Handles
Sample No.	S0004	Material	Resin
Floor	First Basement Level	Asbestos Type	No Asbestos Detected
Room No.	08	Extent	-
Room ID	Switch Room	Notes:

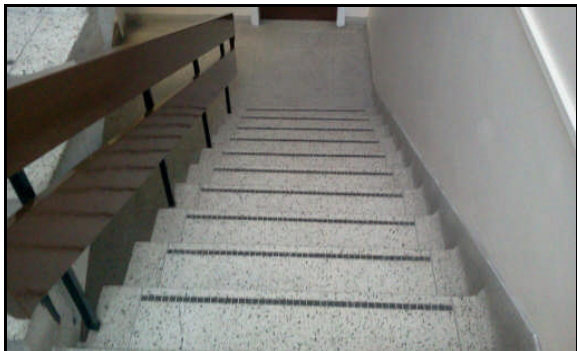
Building ID	Joint Valuation Board & Education Resource Centre	Item Description	Composite Flooring
Sample No.	S0005	Material	Composite Flooring
Floor	First Basement Level	Asbestos Type	No Asbestos Detected
Room No.	10	Extent	-
Room ID	Stairwell	Notes:

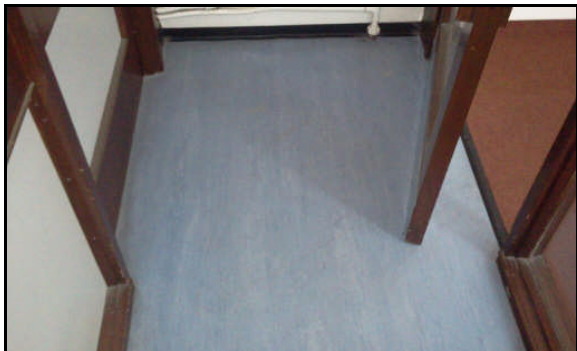
Building ID	Joint Valuation Board & Education Resource Centre	Item Description	Blue Vinyl Floor Covering
Sample No.	S0007	Material	Vinyl Product
Floor	Ground Floor	Asbestos Type	No Asbestos Detected
Room No.	12	Extent	-
Room ID	Fire Escape	Notes:

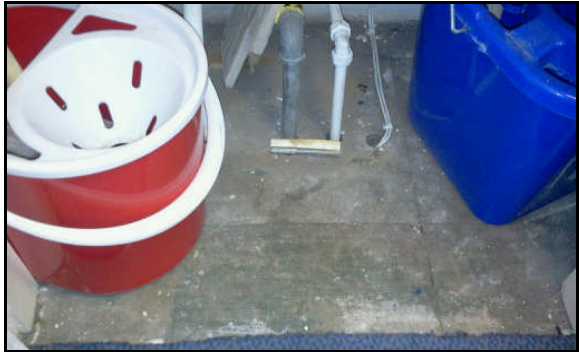
Building ID	Joint Valuation Board & Education Resource Centre	Item Description	Brown Vinyl Floor Tiles
Sample No.	S0011	Material	Vinyl Product
Floor	Ground Floor	Asbestos Type	No Asbestos Detected
Room No.	20	Extent	-
Room ID	Boiler Cupboard	Notes:

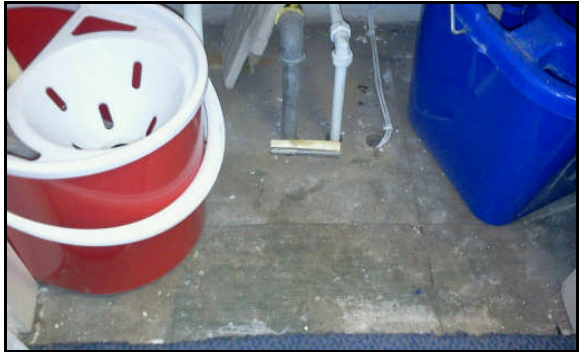
Building ID	Joint Valuation Board & Education Resource Centre	Item Description	Adhesive On Brown Vinyl Floor Tiles
Sample No.	S0012	Material	Adhesive
Floor	Ground Floor	Asbestos Type	No Asbestos Detected
Room No.	20	Extent	-
Room ID	Boiler Cupboard	Notes:

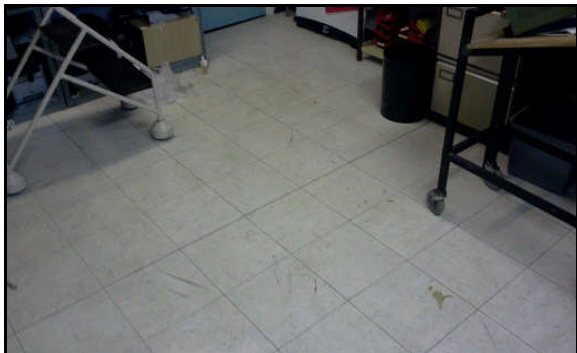
Building ID	Joint Valuation Board & Education Resource Centre	Item Description	White Vinyl Floor Tiles
Sample No.	S0013	Material	Vinyl Product
Floor	Ground Floor	Asbestos Type	No Asbestos Detected
Room No.	21	Extent	-
Room ID	Main Store	Notes: No access was gained to the ceiling void due to fixed MMMF ceiling tiles, therefore it is presumed to contain asbestos until proven otherwise.

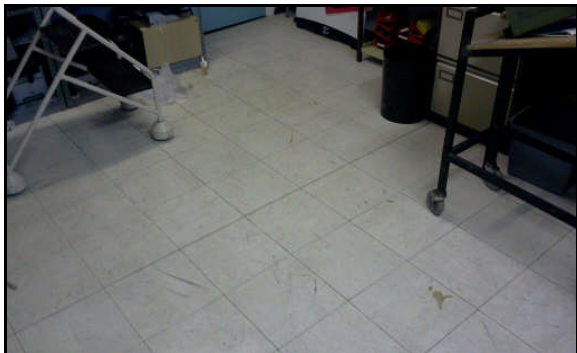
Building ID	Joint Valuation Board & Education Resource Centre	Item Description	Adhesive On White Vinyl Floor Tiles
Sample No.	S0014	Material	Adhesive
Floor	Ground Floor	Asbestos Type	No Asbestos Detected
Room No.	21	Extent	-
Room ID	Main Store	Notes: No access was gained to the ceiling void due to fixed MMMF ceiling tiles, therefore it is presumed to contain asbestos until proven otherwise.

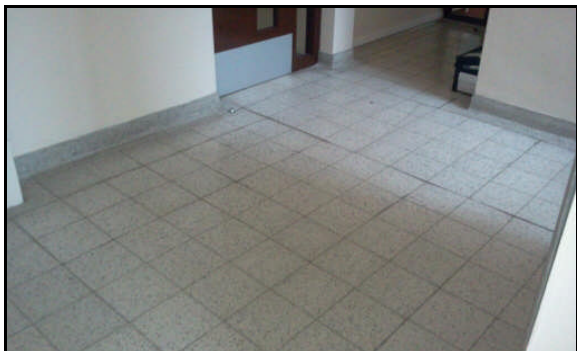
Building ID	Joint Valuation Board & Education Resource Centre	Item Description	Composite Flooring
Sample No.	As S0001	Material	Composite Flooring
Floor	Ground Floor	Asbestos Type	No Asbestos Detected
Room No.	23	Extent	-
Room ID	Landing & Stairs	Notes: No access was gained within the live electrics for safety reasons, therefore asbestos is presumed to be present until proven otherwise.

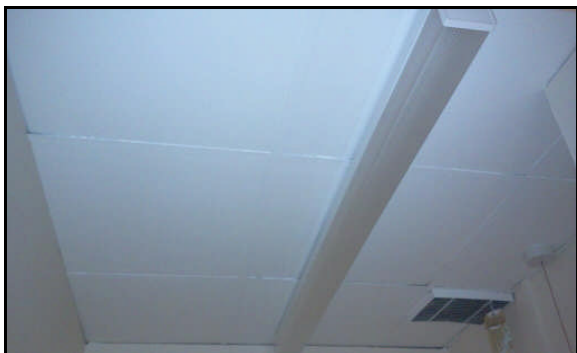
Building ID	Joint Valuation Board & Education Resource Centre	Item Description	Insulating Board Tiles
Sample No.	S0015	Material	Insulating Board
Floor	Ground Floor	Asbestos Type	No Asbestos Detected
Room No.	25	Extent	-
Room ID	Disabled Toilet	Notes:

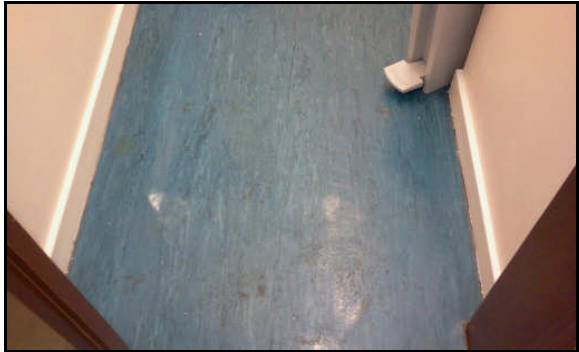
Building ID	Joint Valuation Board & Education Resource Centre	Item Description	Blue Vinyl Floor Covering
Sample No.	S0016	Material	Vinyl Product
Floor	Ground Floor	Asbestos Type	No Asbestos Detected
Room No.	25	Extent	-
Room ID	Disabled Toilet	Notes:

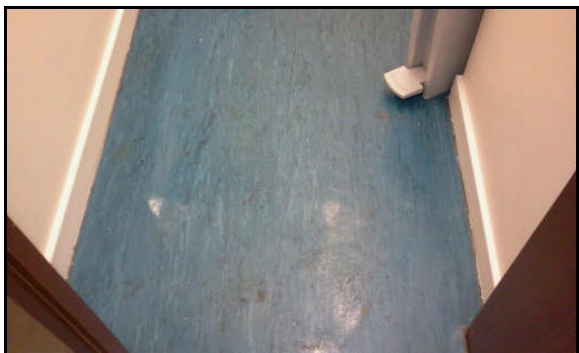
Building ID	Joint Valuation Board & Education Resource Centre	Item Description	Adhesive On Blue Vinyl Floor Covering
Sample No.	S0017	Material	Adhesive
Floor	Ground Floor	Asbestos Type	No Asbestos Detected
Room No.	25	Extent	-
Room ID	Disabled Toilet	Notes:

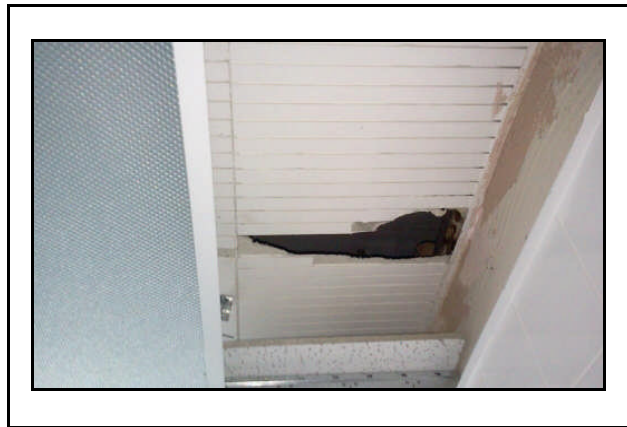
The asbestos insulating board ceiling tiles found in the ceiling void of the Ladies Toilet (ref 65) contain Amosite & Chrysotile. The material has medium levels of damage. It is recommended that for the immediate future remedial works are carried out, however if the material is likely to be disturbed by any future works it should be considered for removal.

HSG 264 Material Assessment Scores				Priority Assessment Scores			Risk Priority Rating:
Product:	2	Condition:	2	Occupant Activity:	1	Likelihood of Disturbance:	2
Surface Treatment:	2	Asbestos Type:	2	Potential of Human Exposure:	1	Maintenance Activity:	1
Material Score:	8	Material Category:	B	Priority Score:	5	Total Score (Overall):	13

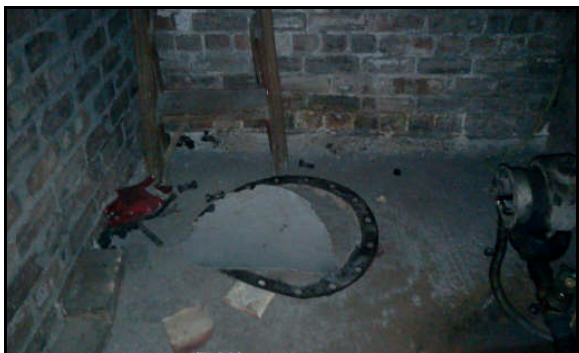
The loose lying gasket found in the Oil Tank Room (ref 87) contains Chrysotile. Although the material is in good condition, it should be removed as it is lying as debris on the floor.

Surveyor:	Donald Campbell
		Recommendation:	Remove
