Joint Valuation Board Offices

235 Dumbarton Road, Clydebank G84 4XJ

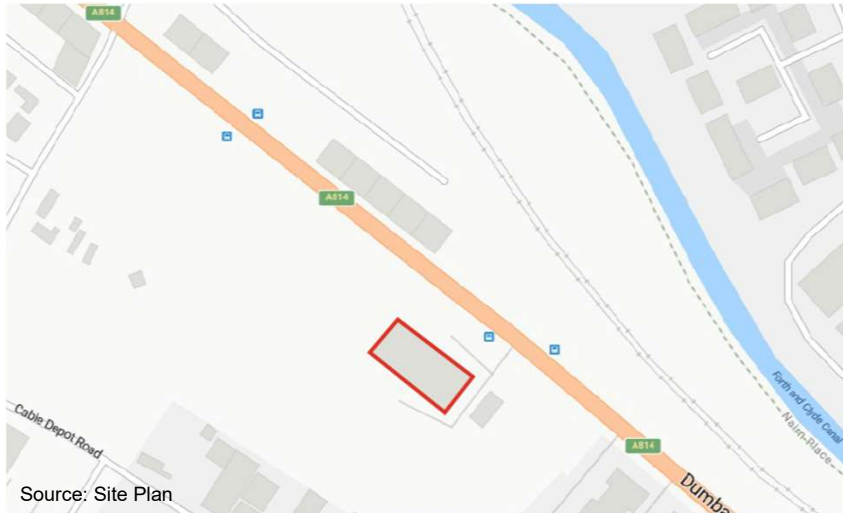
SITE PLAN KEY	
1	RAAC evident or firmly suspected (RED)
2	RAAC to be confirmed (AMBER)
3	Confirmed no RAAC evident (GREEN)
4	RAAC evident but with structural mitigation in place (either temporary or permanent works) (BLUE)

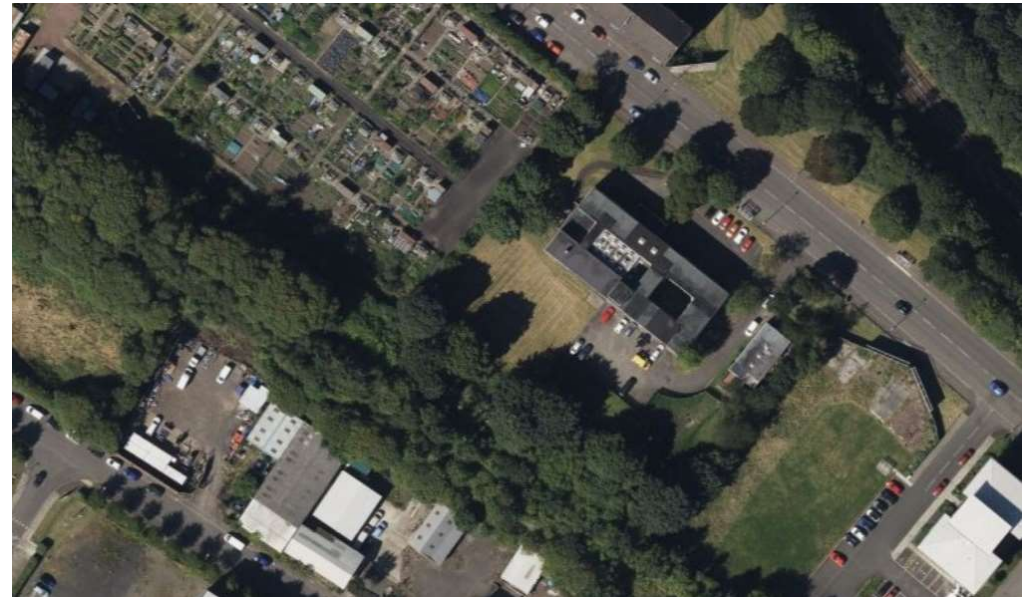
Aerial photograph of site Google Maps (2023)

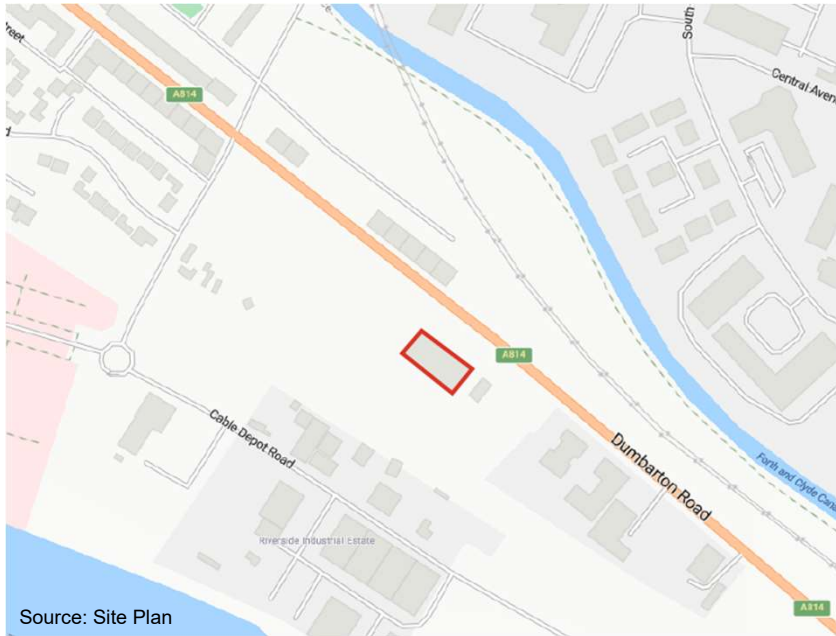
Joint Valuation Board Offices

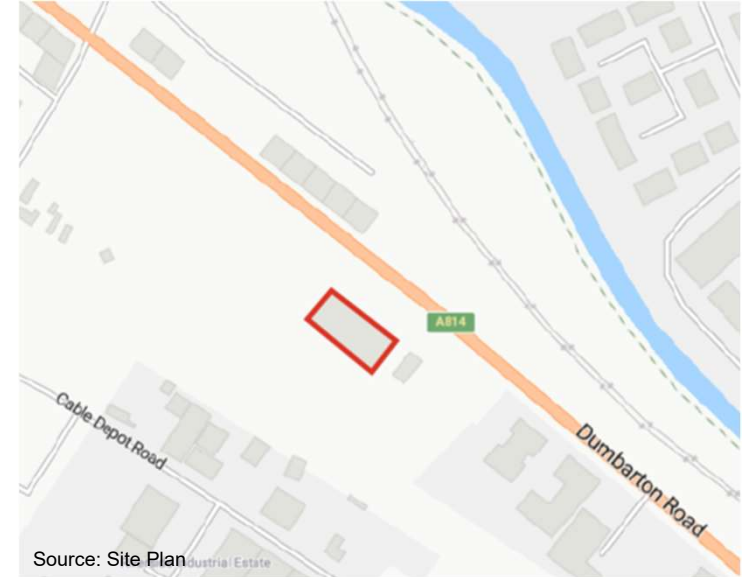
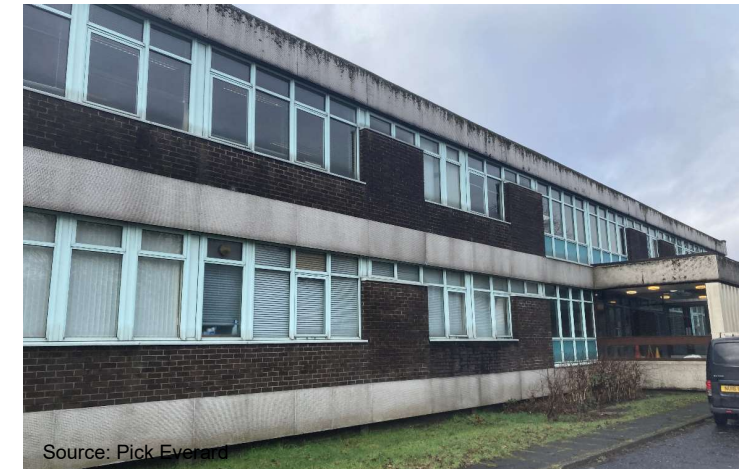
Joint Valuation Board Offices

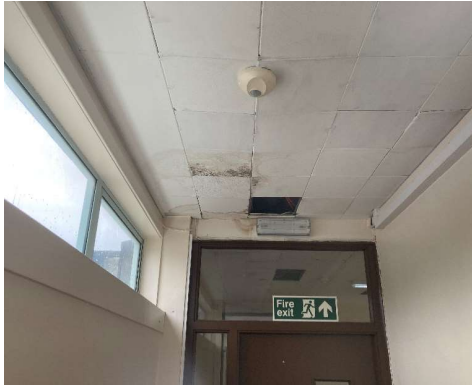
Structural Areas of Concern Photo 1
Water-stained and damaged / missing ceiling tiles resulting from water ingress

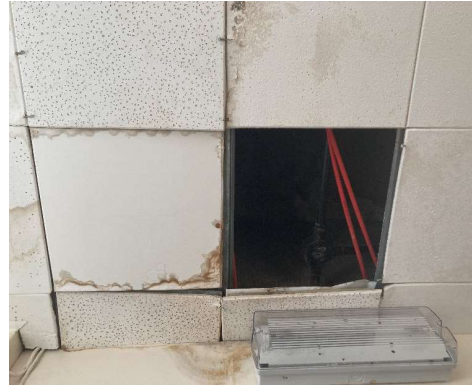
Structural Areas of Concern Photo 3
Water-stained and damaged / missing ceiling finish through water ingress

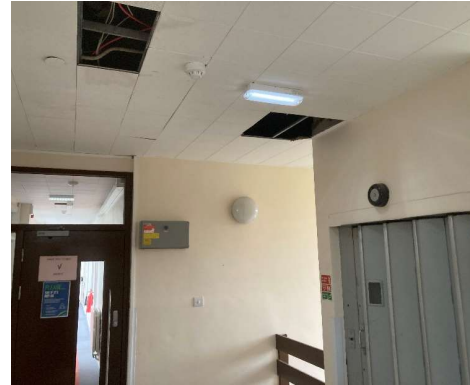
Structural Areas of Concern Photo 5
Water-stained and missing ceiling tiles from excess water ingress

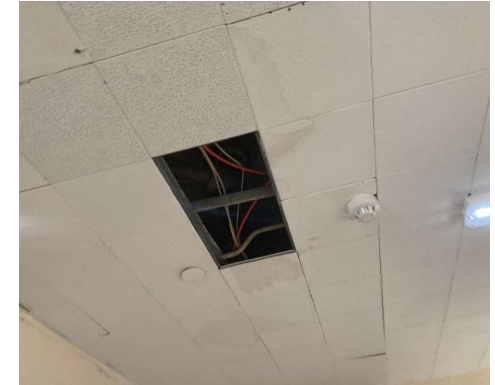
Structural Areas of Concern Photo 7
Water-stained and missing ceiling finish through water ingress

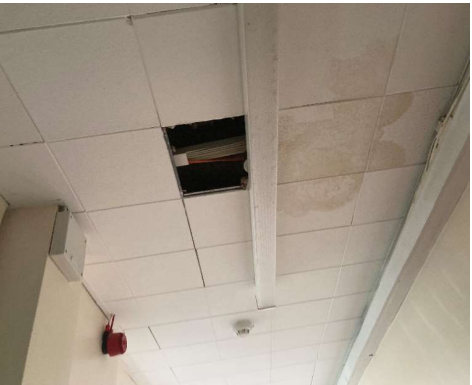
Structural Areas of Concern Photo 2
Water-stained and damaged ceiling finish through water ingress

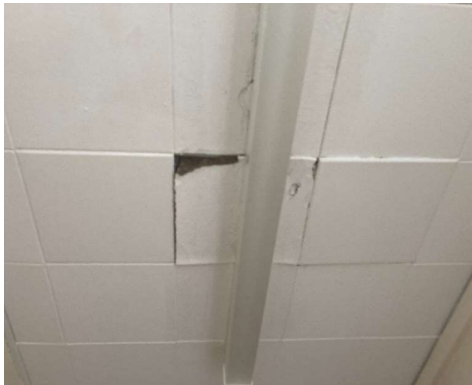
Structural Areas of Concern Photo 4
Water damaged ceiling finish through water ingress

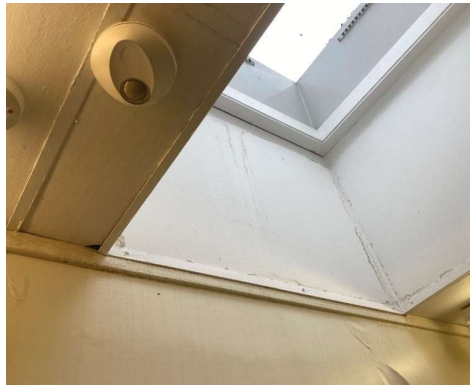
Structural Areas of Concern Photo 6
Water stained and damaged ceiling and wall finish at roof lights

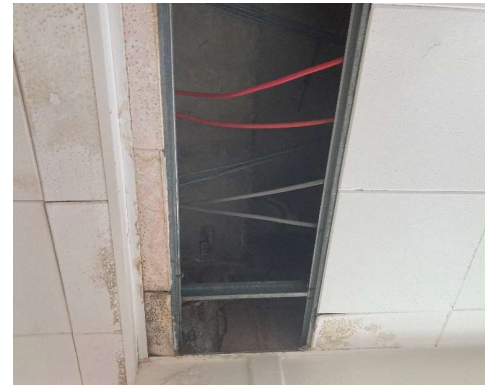
Structural Areas of Concern Photo 8
Damaged ceiling finish through water ingress

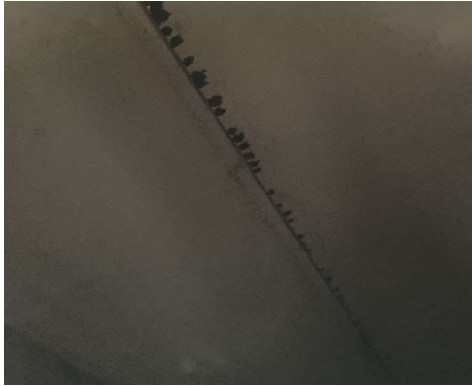
RAAC Observation Photo 1
Hairline cracking noted along chamfer of slab

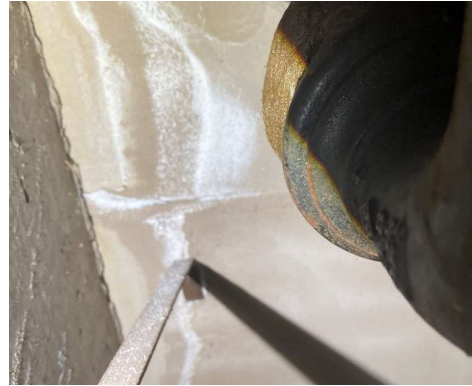
RAAC Observation Photo 3
Penetration through slab, evidence of water ingress at slab edge

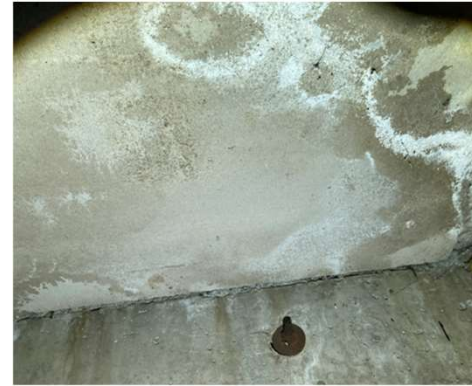
RAAC Observation Photo 5
Extensive water-stained noted throughout

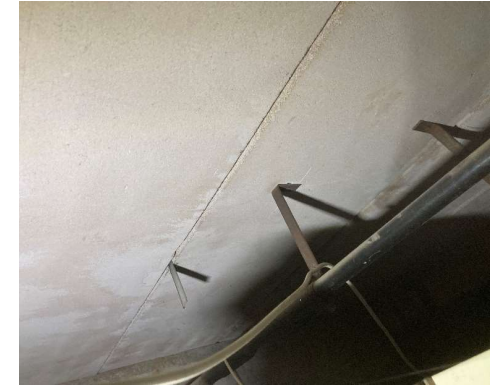
RAAC Observation Photo 7
Suspended grid and services fixed to slab underside

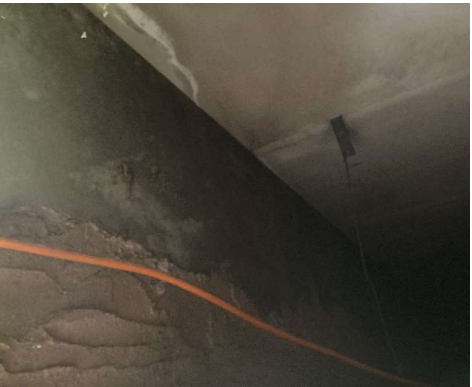
RAAC Observation Photo 2
Water-stained noted at slab edge

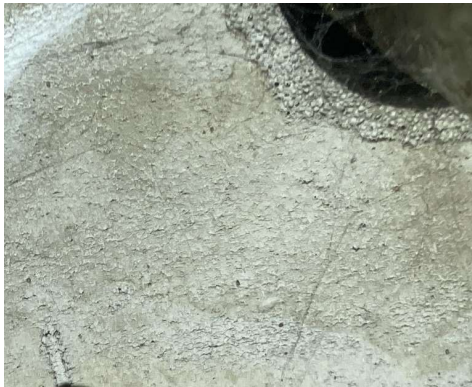
RAAC Observation Photo 4
Penetration through slab

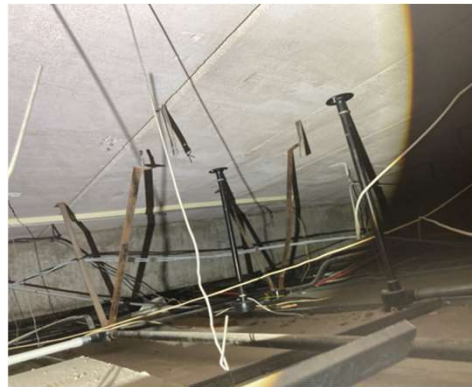
RAAC Observation Photo 6
Failed fixings noted to the slab

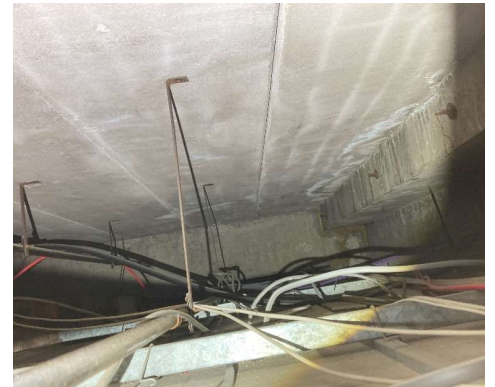
RAAC Observation Photo 8
Minimal coverage of reinforcement with evidence of its location on the surface

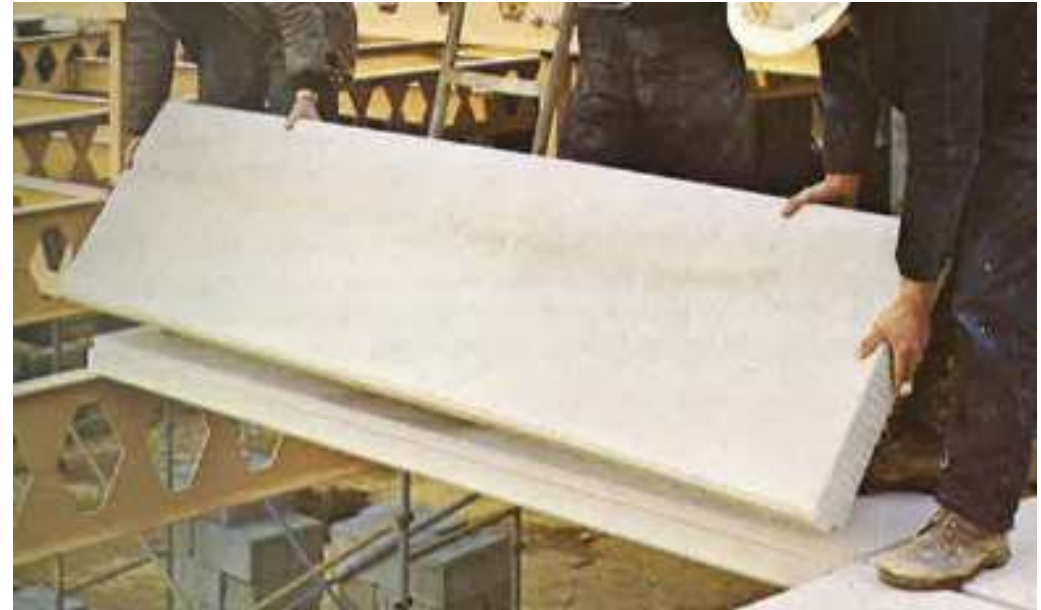
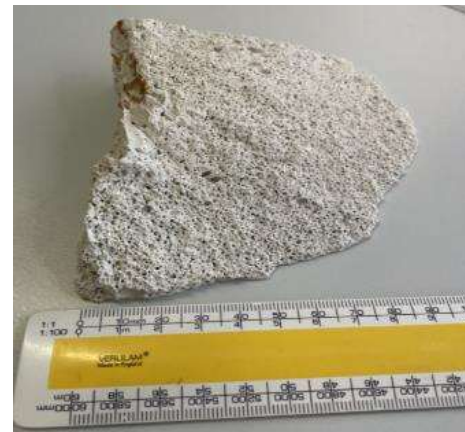
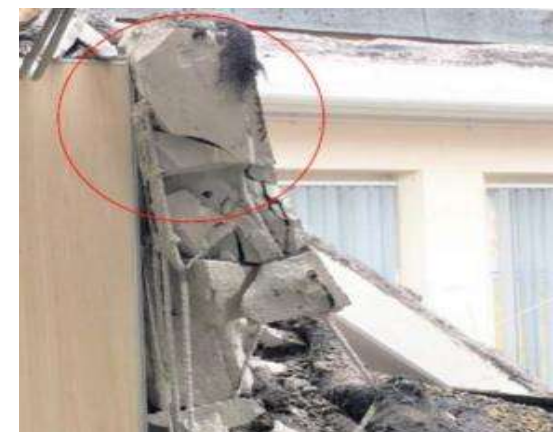
Joint Valuation Board Offices
