Asbestos Management Survey
At
**Joint Valuation Board and Education Resource Centre,
235 Dumbarton Road, Clydebank**

Customer: West Dunbartonshire Council

Project No: G13-00301

Report Issue Date: 14 June 2013

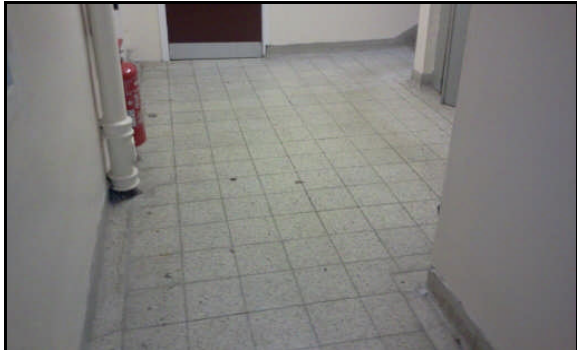
Building ID	Joint Valuation Board & Education Resource Centre	Item Description	Composite Flooring
Sample No.	S0001	Material	Composite Flooring
Floor	First Basement Level	Asbestos Type	No Asbestos Detected
Room No.	01	Extent	-
Room ID	Stairwell & Exit	Notes: No access was gained within the live electrics for safety reasons, therefore asbestos must be presumed to be present until proven otherwise.

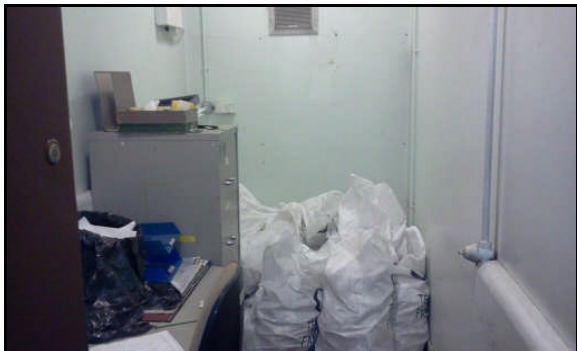
Building ID	Joint Valuation Board & Education Resource Centre	Item Description	No Suspect Materials Seen
Sample No.	-	Material	-
Floor	First Basement Level	Asbestos Type	-
Room No.	02	Extent	-
Room ID	Office	Notes:

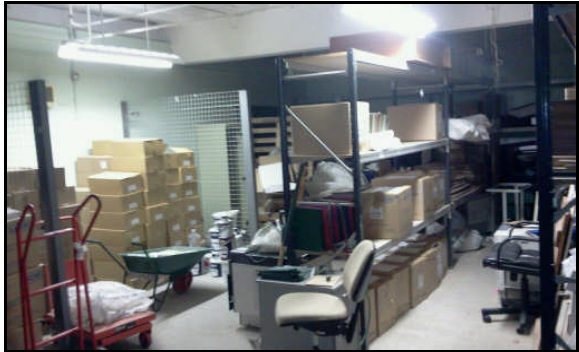
Building ID	Joint Valuation Board & Education Resource Centre	Item Description	No Suspect Materials Seen
Sample No.	-	Material	-
Floor	First Basement Level	Asbestos Type	-
Room No.	03	Extent	-
Room ID	Store	Notes:

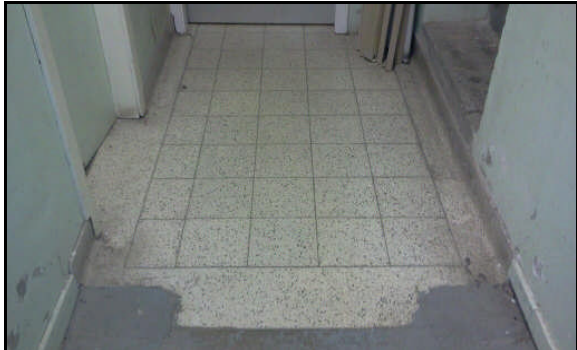
Building ID	Joint Valuation Board & Education Resource Centre	Item Description	Composite Flooring
Sample No.	S0003	Material	Composite Flooring
Floor	First Basement Level	Asbestos Type	No Asbestos Detected
Room No.	05	Extent	-
Room ID	Corridor	Notes:

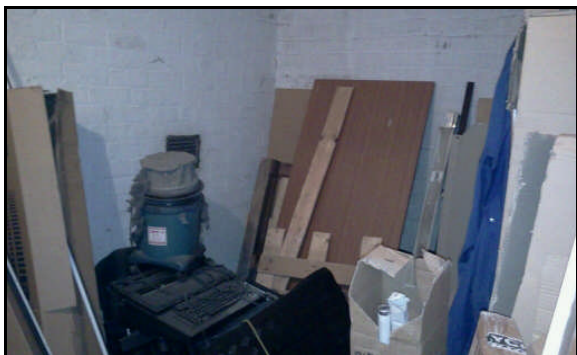
Building ID	Joint Valuation Board & Education Resource Centre	Item Description	No Suspect Materials Seen
Sample No.	-	Material	-
Floor	First Basement Level	Asbestos Type	-
Room No.	06	Extent	-
Room ID	Store	Notes:

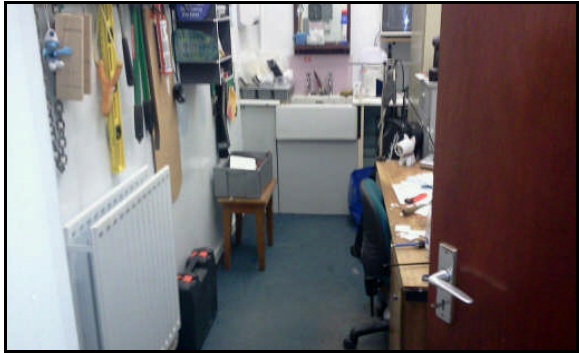
Building ID	Joint Valuation Board & Education Resource Centre	Item Description	No Suspect Materials Seen
Sample No.	-	Material	-
Floor	First Basement Level	Asbestos Type	-
Room No.	07	Extent	-
Room ID	Caretaker's Office	Notes:

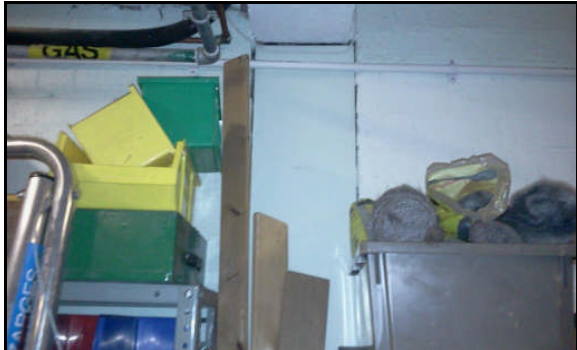
Building ID	Joint Valuation Board & Education Resource Centre	Item Description	No Suspect Materials Seen
Sample No.	-	Material	-
Floor	First Basement Level	Asbestos Type	-
Room No.	09	Extent	-
Room ID	Central Store	Notes: No access was gained within the timber riser on wall 4 due to the irreparable damage that would be caused, therefore asbestos must be presumed to be present until proven otherwise.

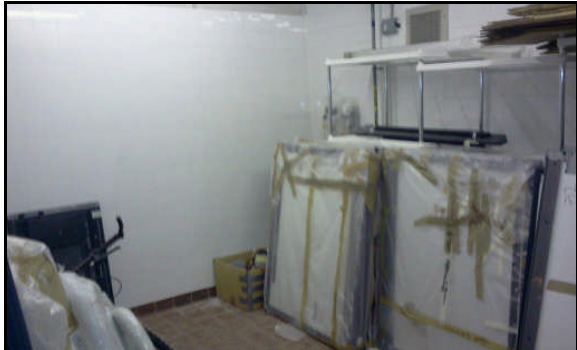
Building ID	Joint Valuation Board & Education Resource Centre	Item Description	Ceramic Tile Adhesive On Walls
Sample No.	S0006	Material	Adhesive
Floor	First Basement Level	Asbestos Type	No Asbestos Detected
Room No.	11	Extent	-
Room ID	Store	Notes:

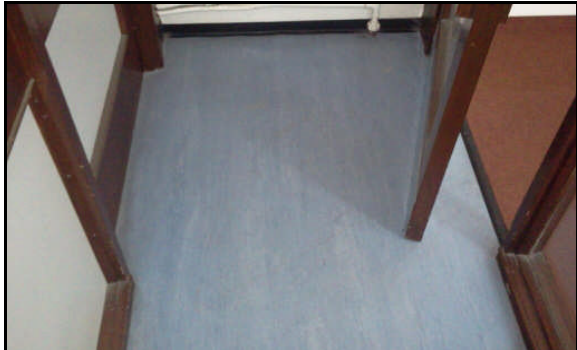
Building ID	Joint Valuation Board & Education Resource Centre	Item Description	Adhesive On Blue Vinyl Floor Covering
Sample No.	S0008	Material	Adhesive
Floor	Ground Floor	Asbestos Type	No Asbestos Detected
Room No.	12	Extent	-
Room ID	Fire Escape	Notes: No access was gained to the ceiling void due to fixed MMMF ceiling tiles, therefore it is presumed to contain asbestos until proven otherwise.

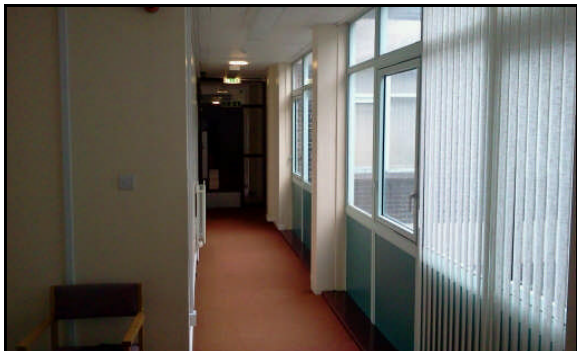
Building ID	Joint Valuation Board & Education Resource Centre	Item Description	No Suspect Materials Seen
Sample No.	-	Material	-
Floor	Ground Floor	Asbestos Type	-
Room No.	13	Extent	-
Room ID	Corridor	Notes: No access was gained to the ceiling void due to fixed MMMF ceiling tiles, therefore it is presumed to contain asbestos until proven otherwise.

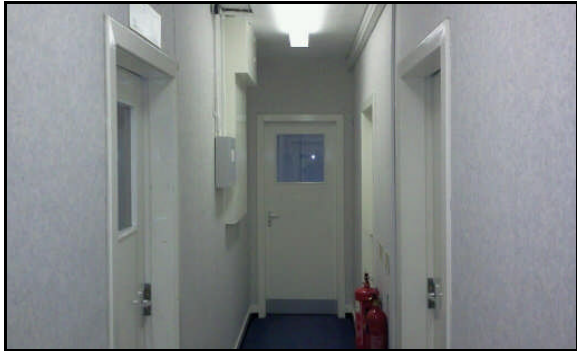
Building ID	Joint Valuation Board & Education Resource Centre	Item Description	No Suspect Materials Seen
Sample No.	-	Material	-
Floor	Ground Floor	Asbestos Type	-
Room No.	14	Extent	-
Room ID	Corridor	Notes:	No access was gained to the ceiling void due to fixed MMMF ceiling tiles, therefore it is presumed to contain asbestos until proven otherwise.

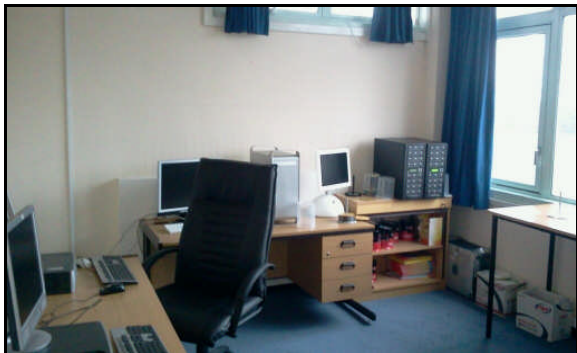
Building ID	Joint Valuation Board & Education Resource Centre	Item Description	No Suspect Materials Seen
Sample No.	-	Material	-
Floor	Ground Floor	Asbestos Type	-
Room No.	15	Extent	-
Room ID	Office	Notes:	No access was gained to the ceiling void due to fixed MMMF ceiling tiles, therefore it is presumed to contain asbestos until proven otherwise.

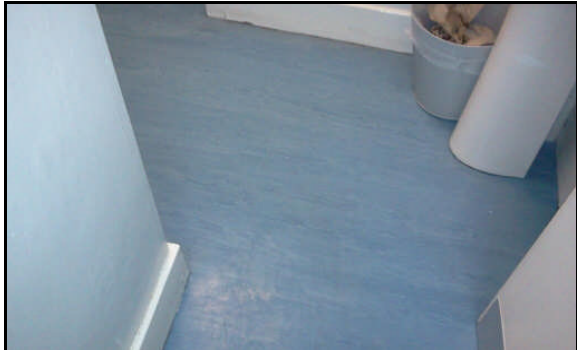
Building ID	Joint Valuation Board & Education Resource Centre	Item Description	Blue Vinyl Floor Covering
Sample No.	S0009	Material	Vinyl Product
Floor	Ground Floor	Asbestos Type	No Asbestos Detected
Room No.	16	Extent	-
Room ID	Gents Toilet	Notes:

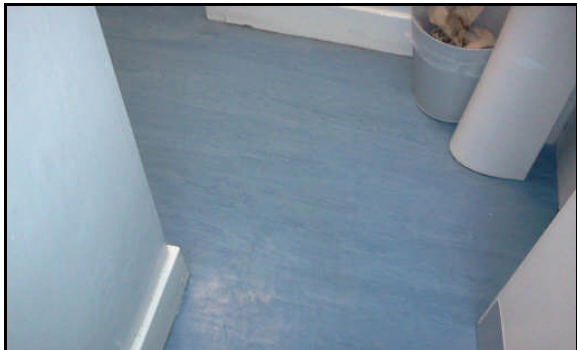
Building ID	Joint Valuation Board & Education Resource Centre	Item Description	Adhesive On Blue Vinyl Floor Covering
Sample No.	S0010	Material	Adhesive
Floor	Ground Floor	Asbestos Type	No Asbestos Detected
Room No.	16	Extent	-
Room ID	Gents Toilet	Notes:

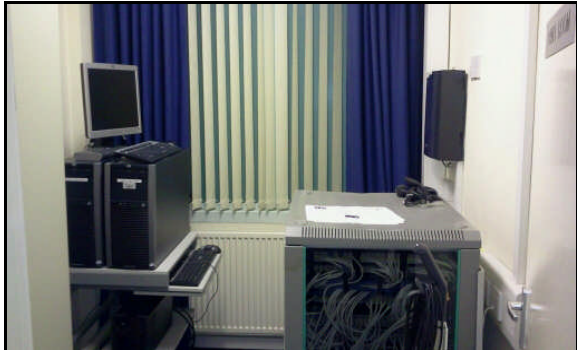
Building ID	Joint Valuation Board & Education Resource Centre	Item Description	No Suspect Materials Seen
Sample No.	-	Material	-
Floor	Ground Floor	Asbestos Type	-
Room No.	18	Extent	-
Room ID	Panel Room	Notes: No access was gained below the fixed carpet due to the irreparable damage that would be caused. It should therefore be presumed to contain asbestos until proven otherwise.

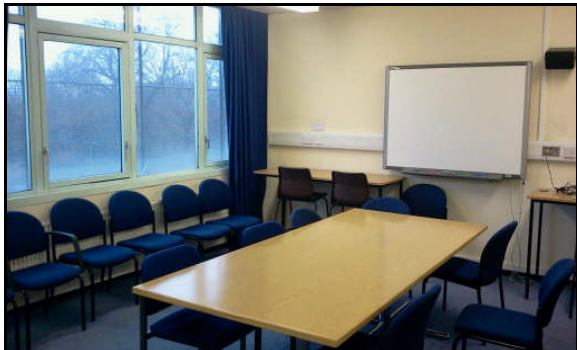
Building ID	Joint Valuation Board & Education Resource Centre	Item Description	No Suspect Materials Seen
Sample No.	-	Material	-
Floor	Ground Floor	Asbestos Type	-
Room No.	19	Extent	-
Room ID	Training Room	Notes: No access was gained below the fixed carpet due to the irreparable damage that would be caused. It should therefore be presumed to contain asbestos until proven otherwise. No access was gained to the ceiling void due to fixed MMMF ceiling tiles, therefore it is presumed to contain asbestos until proven otherwise.

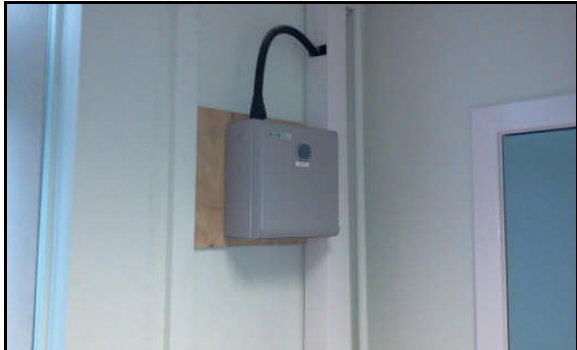
Building ID	Joint Valuation Board & Education Resource Centre	Item Description	No Suspect Materials Seen
Sample No.	-	Material	-
Floor	Ground Floor	Asbestos Type	-
Room No.	22	Extent	-
Room ID	Office	Notes: No access was gained below the fixed carpet due to the irreparable damage that would be caused. It should therefore be presumed to contain asbestos until proven otherwise. No access was gained within the live electrics for safety reasons, therefore asbestos is presumed present until proven otherwise.

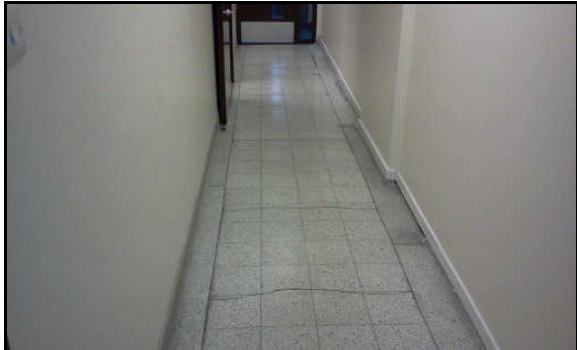
Building ID	Joint Valuation Board & Education Resource Centre	Item Description	Composite Flooring
Sample No.	As S0001	Material	Composite Flooring
Floor	Ground Floor	Asbestos Type	No Asbestos Detected
Room No.	24	Extent	-
Room ID	Corridor	Notes: No access was gained to the ceiling void due to fixed MMMF ceiling tiles, therefore it is presumed to contain asbestos until proven otherwise.

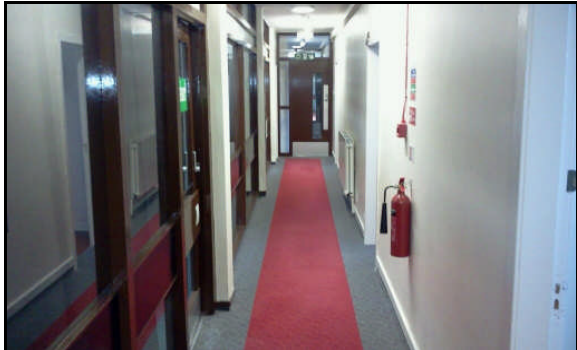
Building ID	Joint Valuation Board & Education Resource Centre	Item Description	No Suspect Materials Seen
Sample No.	-	Material	-
Floor	Ground Floor	Asbestos Type	-
Room No.	26	Extent	-
Room ID	Corridor	Notes: No access was gained below the fixed carpet due to the irreparable damage that would be caused. It should therefore be presumed to contain asbestos until proven otherwise. No access was gained to the ceiling void due to fixed MMMF ceiling tiles, therefore it is presumed to contain asbestos until proven otherwise.

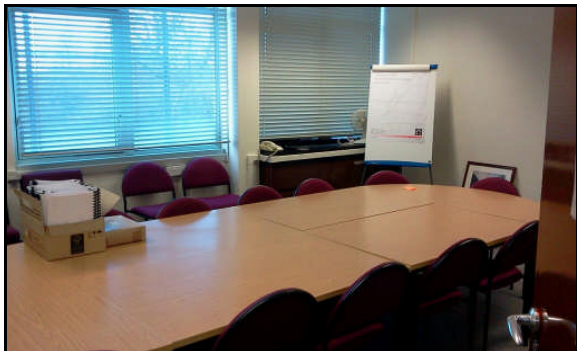
Building ID	Joint Valuation Board & Education Resource Centre	Item Description	No Suspect Materials Seen
Sample No.	-	Material	-
Floor	Ground Floor	Asbestos Type	-
Room No.	27	Extent	-
Room ID	Meeting Room	Notes: No access was gained below the fixed carpet due to the irreparable damage that would be caused. It should therefore be presumed to contain asbestos until proven otherwise. No access was gained to the ceiling void due to fixed MMMF ceiling tiles, therefore it is presumed to contain asbestos until proven otherwise.

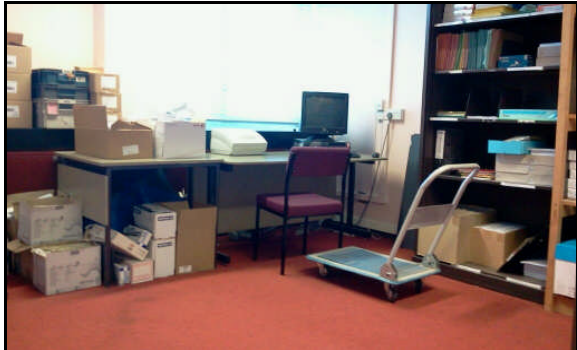
Building ID	Joint Valuation Board & Education Resource Centre	Item Description	No Suspect Materials Seen
Sample No.	-	Material	-
Floor	Ground Floor	Asbestos Type	-
Room No.	28	Extent	-
Room ID	Store	Notes: No access was gained below the fixed carpet due to the irreparable damage that would be caused. It should therefore be presumed to contain asbestos until proven otherwise. No access was gained to the ceiling void due to fixed MMMF ceiling tiles, therefore it is presumed to contain asbestos until proven otherwise.

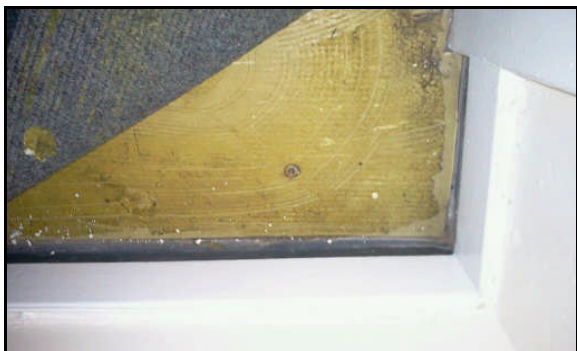
Building ID	Joint Valuation Board & Education Resource Centre	Item Description	Yellow Vinyl Floor Covering Below Carpet
Sample No.	S0018	Material	Vinyl Product
Floor	Ground Floor	Asbestos Type	No Asbestos Detected
Room No.	29	Extent	-
Room ID	Library	Notes: No access was gained to the ceiling void due to fixed MMMF ceiling tiles, therefore it is presumed to contain asbestos until proven otherwise. No access was gained within the timber riser & boxing on walls 3/4, or within the timber riser on wall 6 due to the irreparable damage that would be caused. These must therefore be presumed to contain asbestos until proven otherwise.

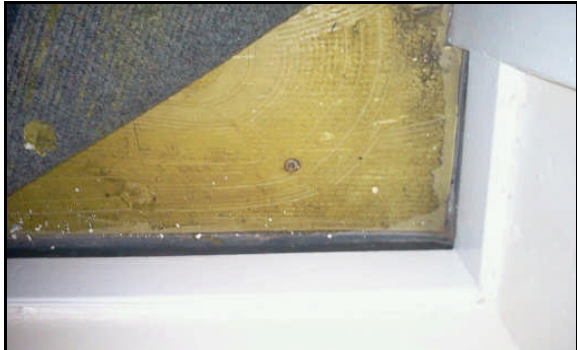
Building ID	Joint Valuation Board & Education Resource Centre	Item Description	Adhesive On Yellow Vinyl Floor Covering Below Carpet
Sample No.	S0019	Material	Adhesive
Floor	Ground Floor	Asbestos Type	No Asbestos Detected
Room No.	29	Extent	-
Room ID	Library	Notes: No access was gained to the ceiling void due to fixed MMMF ceiling tiles, therefore it is presumed to contain asbestos until proven otherwise. No access was gained within the timber riser & boxing on walls 3/4, or within the timber riser on wall 6 due to the irreparable damage that would be caused. These must therefore be presumed to contain asbestos until proven otherwise.

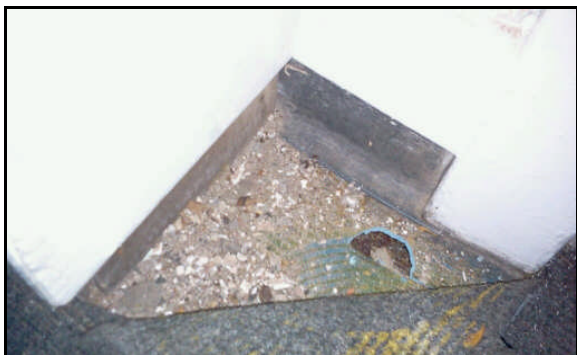
Building ID	Joint Valuation Board & Education Resource Centre	Item Description	Blue Vinyl Floor Covering Below Carpet
Sample No.	S0020	Material	Vinyl Product
Floor	Ground Floor	Asbestos Type	No Asbestos Detected
Room No.	30	Extent	-
Room ID	Office	Notes: No access was gained to the ceiling void due to fixed MMMF ceiling tiles, therefore it is presumed to contain asbestos until proven otherwise.

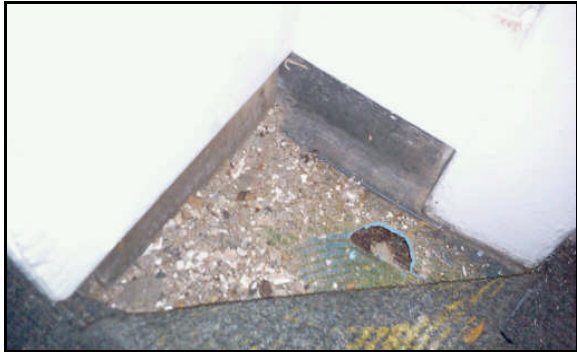
Building ID	Joint Valuation Board & Education Resource Centre	Item Description	Adhesive On Blue Vinyl Floor Covering Below Carpet
Sample No.	S0021	Material	Adhesive
Floor	Ground Floor	Asbestos Type	No Asbestos Detected
Room No.	30	Extent	-
Room ID	Office	Notes: No access was gained to the ceiling void due to fixed MMMF ceiling tiles, therefore it is presumed to contain asbestos until proven otherwise.

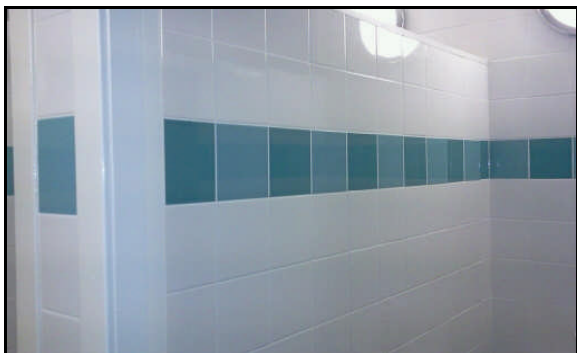
Building ID	Joint Valuation Board & Education Resource Centre	Item Description	Ceramic Tile Adhesive On Walls
Sample No.	S0022	Material	Adhesive
Floor	Ground Floor	Asbestos Type	No Asbestos Detected
Room No.	31	Extent	-
Room ID	Ladies Toilet	Notes:

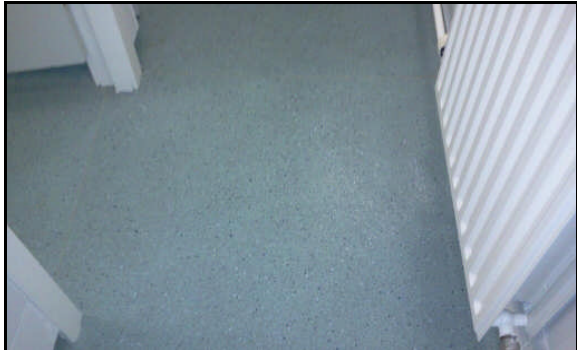
Building ID	Joint Valuation Board & Education Resource Centre	Item Description	Green Vinyl Floor Covering
Sample No.	S0023	Material	Vinyl Product
Floor	Ground Floor	Asbestos Type	No Asbestos Detected
Room No.	31	Extent	-
Room ID	Ladies Toilet	Notes:

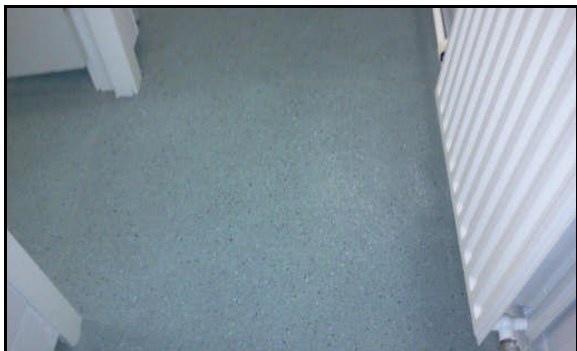
Building ID	Joint Valuation Board & Education Resource Centre	Item Description	Adhesive On Green Vinyl Floor Covering
Sample No.	S0024	Material	Adhesive
Floor	Ground Floor	Asbestos Type	No Asbestos Detected
Room No.	31	Extent	-
Room ID	Ladies Toilet	Notes:

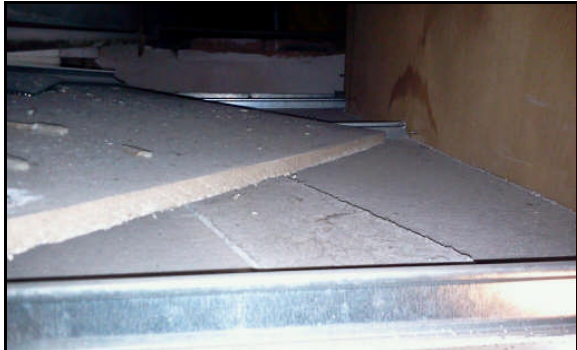
Building ID	Joint Valuation Board & Education Resource Centre	Item Description	Insulating Board Ceiling Tiles In Ceiling Void
Sample No.	S0025	Material	Insulating Board
Floor	Ground Floor	Asbestos Type	No Asbestos Detected
Room No.	31	Extent	-
Room ID	Ladies Toilet	Notes:

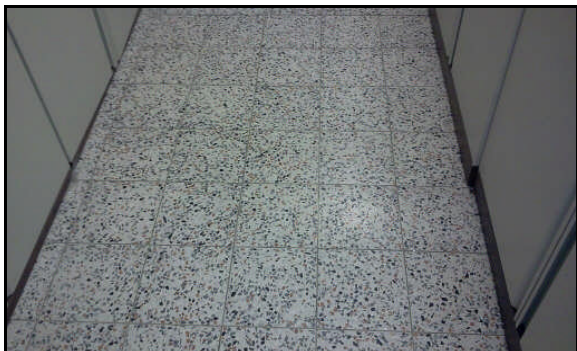
Building ID	Joint Valuation Board & Education Resource Centre	Item Description	Composite Flooring
Sample No.	S0026	Material	Composite Flooring
Floor	Ground Floor	Asbestos Type	No Asbestos Detected
Room No.	32	Extent	-
Room ID	File Room	Notes:

No access was gained within the convection radiators for safety reasons, therefore asbestos is presumed to be present until proven otherwise.	
		No access was gained to the ceiling void due to fixed MMMF ceiling tiles & height restrictions, therefore asbestos is presumed to be present until proven otherwise.	
		Surveyor: Donald Campbell	
		Recommendation: -

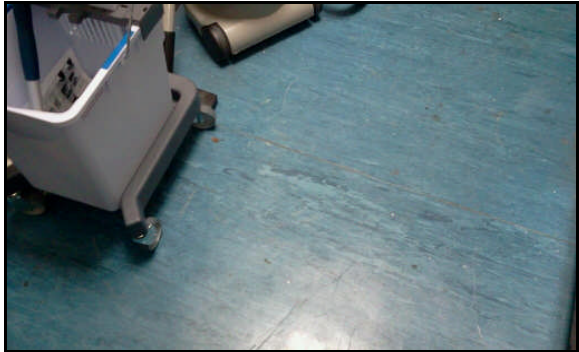
Building ID	Joint Valuation Board & Education Resource Centre	Item Description	Blue Vinyl Floor Covering
Sample No.	S0027	Material	Vinyl Product
Floor	Ground Floor	Asbestos Type	No Asbestos Detected
Room No.	33	Extent	-
Room ID	Cleaner's Store	Notes: No access was gained within the timber riser on walls 5/6 due to the irreparable damage that would be caused, therefore asbestos is presumed to be present until proven otherwise.

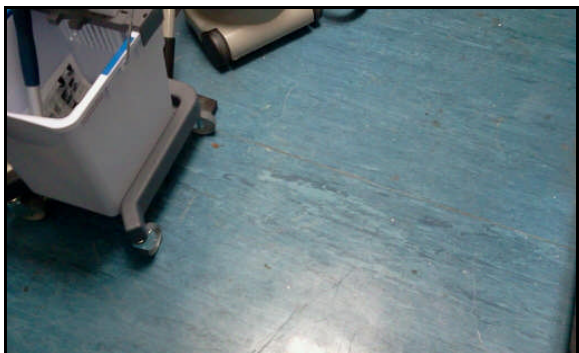
Building ID	Joint Valuation Board & Education Resource Centre	Item Description	Adhesive On Blue Vinyl Floor Covering
Sample No.	S0028	Material	Adhesive
Floor	Ground Floor	Asbestos Type	No Asbestos Detected
Room No.	33	Extent	-
Room ID	Cleaner's Store	Notes: No access was gained within the timber riser on walls 5/6 due to the irreparable damage that would be caused, therefore asbestos is presumed to be present until proven otherwise.

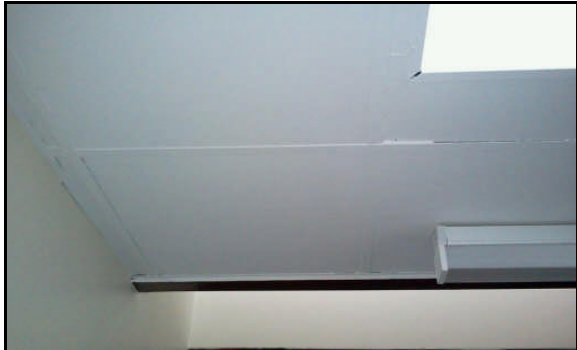
Building ID	Joint Valuation Board & Education Resource Centre	Item Description	Insulating Board Ceiling Tiles
Sample No.	S0029	Material	Insulating Board
Floor	Ground Floor	Asbestos Type	No Asbestos Detected
Room No.	33	Extent	-
Room ID	Cleaner's Store	Notes: No access was gained within the timber riser on walls 5/6 due to the irreparable damage that would be caused, therefore asbestos is presumed to be present until proven otherwise.

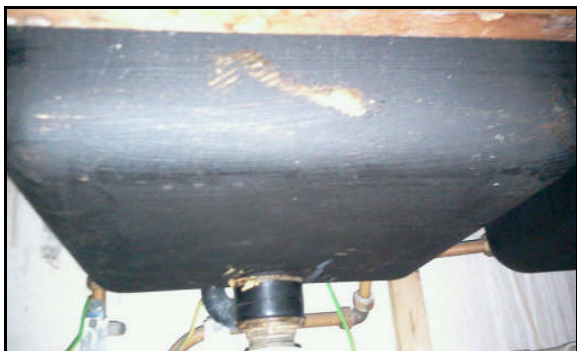
Building ID	Joint Valuation Board & Education Resource Centre	Item Description	Bitumen Coating To Sinks
Sample No.	S0030	Material	Bituminous Products
Floor	Ground Floor	Asbestos Type	No Asbestos Detected
Room No.	33	Extent	-
Room ID	Cleaner's Store	Notes: No access was gained within the timber riser on walls 5/6 due to the irreparable damage that would be caused, therefore asbestos is presumed to be present until proven otherwise.

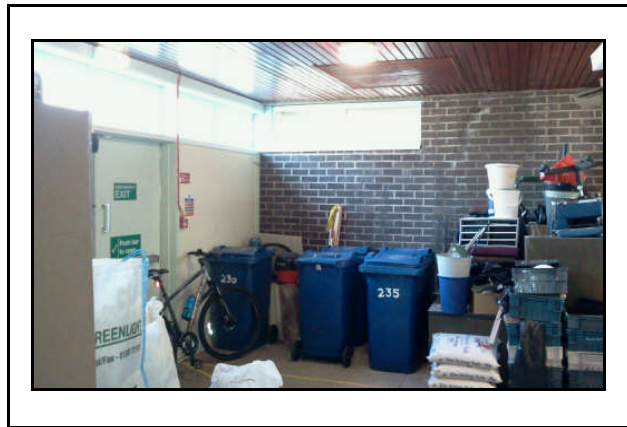
Notes:
No access was gained to the ceiling void due to the fixed timber panelling, therefore asbestos must be presumed to be present until proven otherwise.

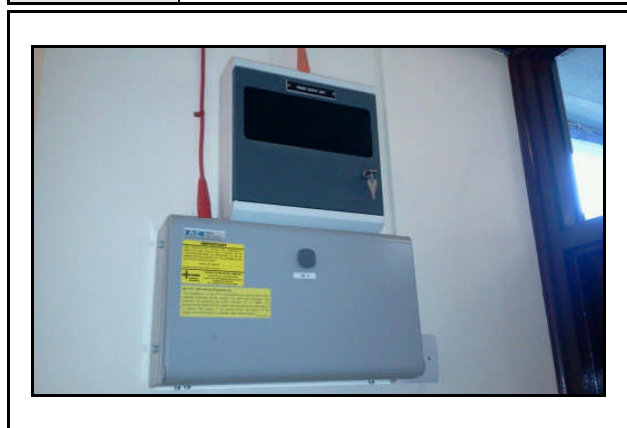
Notes:
No access was gained within the live electrics for safety reasons, therefore asbestos must be presumed to be present until proven otherwise.

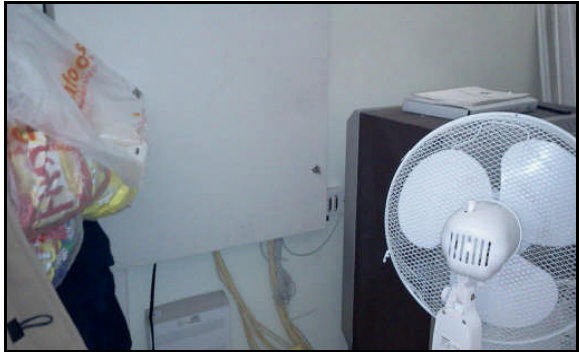
Building ID	Joint Valuation Board & Education Resource Centre	Item Description	No Suspect Materials Seen
Sample No.	-	Material	-
Floor	Ground Floor	Asbestos Type	-
Room No.	36	Extent	-
Room ID	Communications Cupboard	Notes:

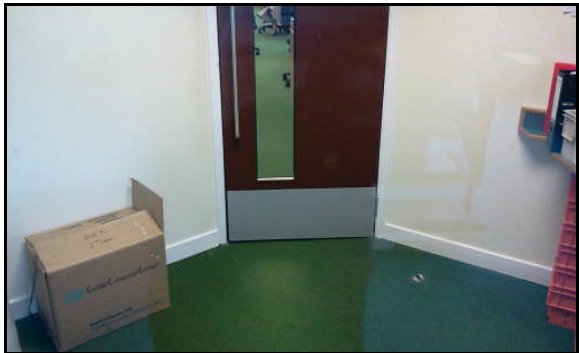
Building ID	Joint Valuation Board & Education Resource Centre	Item Description	No Suspect Materials Seen
Sample No.	-	Material	-
Floor	Ground Floor	Asbestos Type	-
Room No.	37	Extent	-
Room ID	Reception	Notes:

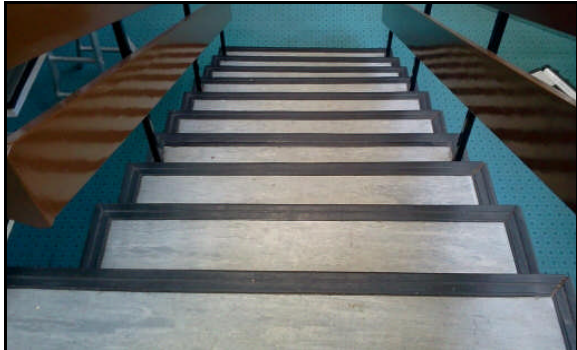
Building ID	Joint Valuation Board & Education Resource Centre	Item Description	Grey Vinyl Floor Covering To Stairs
Sample No.	S0031	Material	Vinyl Product
Floor	Ground Floor	Asbestos Type	No Asbestos Detected
Room No.	38	Extent	-
Room ID	Reception Hall & Stairs	Notes: No access was gained below the fixed carpet due to the irreparable damage that would be caused, therefore it must be presumed to contain asbestos until proven otherwise. No access was gained within the live electrics for safety reasons, therefore asbestos must be presumed to be present until proven otherwise.

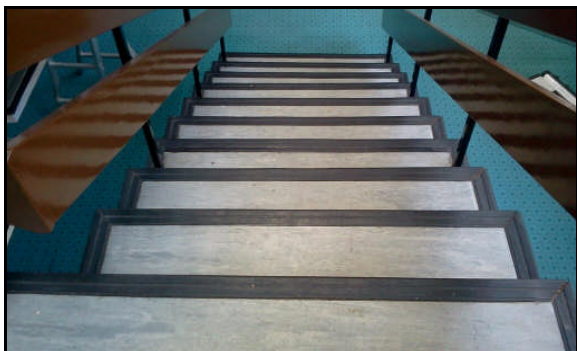
Building ID	Joint Valuation Board & Education Resource Centre	Item Description	Adhesive On Grey Vinyl Floor Covering
Sample No.	S0032	Material	Adhesive
Floor	Ground Floor	Asbestos Type	No Asbestos Detected
Room No.	38	Extent	-
Room ID	Reception Hall & Stairs	Notes: No access was gained below the fixed carpet due to the irreparable damage that would be caused, therefore it must be presumed to contain asbestos until proven otherwise. No access was gained within the live electrics for safety reasons, therefore asbestos must be presumed to be present until proven otherwise.

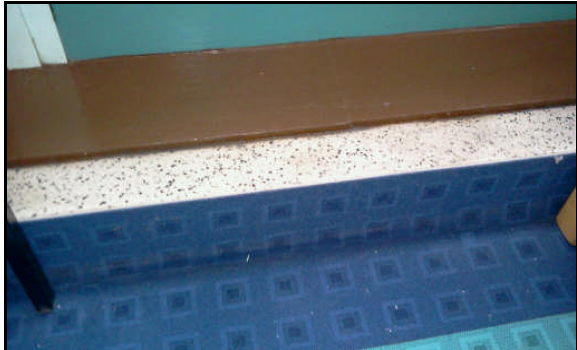
Building ID	Joint Valuation Board & Education Resource Centre	Item Description	Composite Flooring Below Carpet
Sample No.	S0033	Material	Composite Flooring
Floor	Ground Floor	Asbestos Type	No Asbestos Detected
Room No.	38	Extent	-
Room ID	Reception Hall & Stairs	Notes: No access was gained below the fixed carpet due to the irreparable damage that would be caused, therefore it must be presumed to contain asbestos until proven otherwise. No access was gained within the live electrics for safety reasons, therefore asbestos must be presumed to be present until proven otherwise.

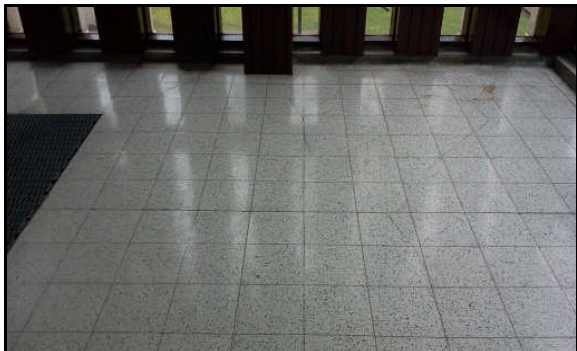
Building ID	Joint Valuation Board & Education Resource Centre	Item Description	Composite Flooring
Sample No.	S0034	Material	Composite Flooring
Floor	Ground Floor	Asbestos Type	No Asbestos Detected
Room No.	39	Extent	-
Room ID	Main Entrance	Notes:

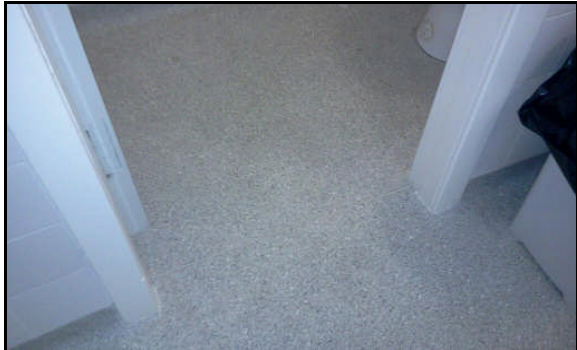
Building ID	Joint Valuation Board & Education Resource Centre	Item Description	Grey Vinyl Floor Covering
Sample No.	S0035	Material	Vinyl Product
Floor	Ground Floor	Asbestos Type	No Asbestos Detected
Room No.	40	Extent	-
Room ID	Gents Toilet	Notes:

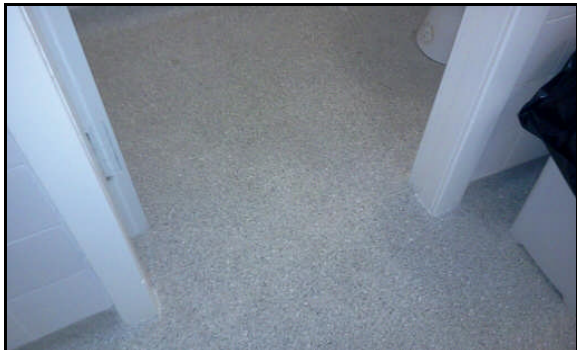
Building ID	Joint Valuation Board & Education Resource Centre	Item Description	Adhesive On Grey Vinyl Floor Covering
Sample No.	S0036	Material	Adhesive
Floor	Ground Floor	Asbestos Type	No Asbestos Detected
Room No.	40	Extent	-
Room ID	Gents Toilet	Notes:

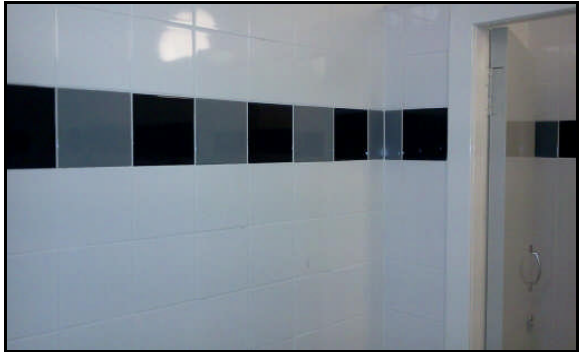
Building ID	Joint Valuation Board & Education Resource Centre	Item Description	Ceramic Tile Adhesive On Walls
Sample No.	S0037	Material	Adhesive
Floor	Ground Floor	Asbestos Type	No Asbestos Detected
Room No.	40	Extent	-
Room ID	Gents Toilet	Notes:

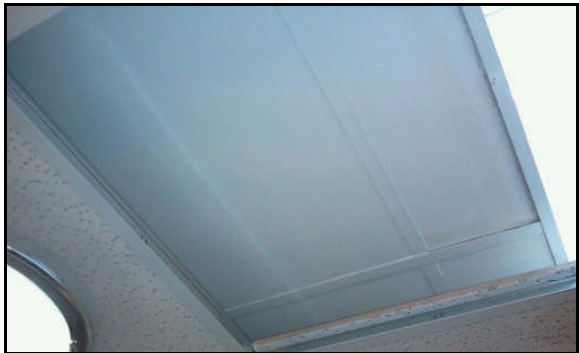
Building ID	Joint Valuation Board & Education Resource Centre	Item Description	Insulating Board Tiles Within Ceiling Void
Sample No.	S0038	Material	Insulating Board
Floor	Ground Floor	Asbestos Type	No Asbestos Detected
Room No.	40	Extent	-
Room ID	Gents Toilet	Notes:

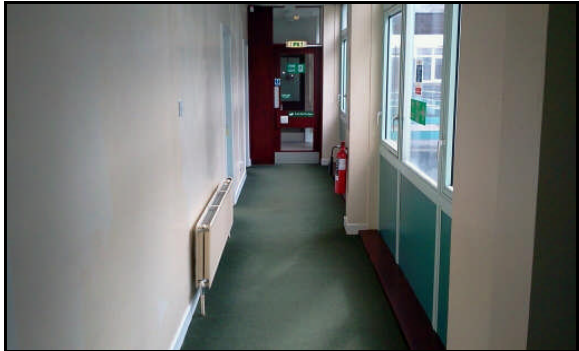
Building ID	Joint Valuation Board & Education Resource Centre	Item Description	No Suspect Materials Seen
Sample No.	-	Material	-
Floor	Ground Floor	Asbestos Type	-
Room No.	41	Extent	-
Room ID	Corridor	Notes:	No access was gained below the fixed carpet due to the irreparable damage that would be caused, therefore it must be presumed to contain asbestos until proven otherwise. No access was gained to the ceiling void due to fixed MMMF ceiling tiles, therefore asbestos is presumed to be present until proven otherwise.

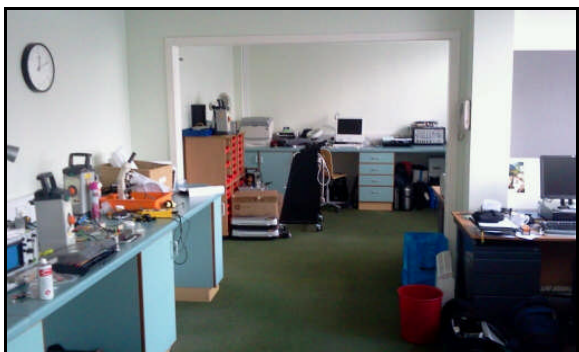
Building ID	Joint Valuation Board & Education Resource Centre	Item Description	No Suspect Materials Seen
Sample No.	-	Material	-
Floor	Ground Floor	Asbestos Type	-
Room No.	42	Extent	-
Room ID	Workshop	Notes:	No access was gained below the fixed carpet due to the irreparable damage that would be caused, therefore it must be presumed to contain asbestos until proven otherwise.

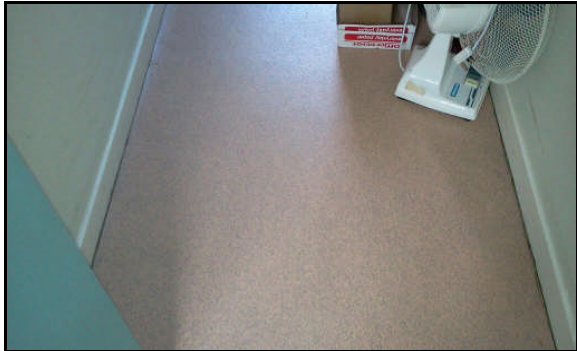
Building ID	Joint Valuation Board & Education Resource Centre	Item Description	Pink Vinyl Floor Covering
Sample No.	S0039	Material	Vinyl Product
Floor	Ground Floor	Asbestos Type	No Asbestos Detected
Room No.	43	Extent	-
Room ID	Vestibule	Notes:

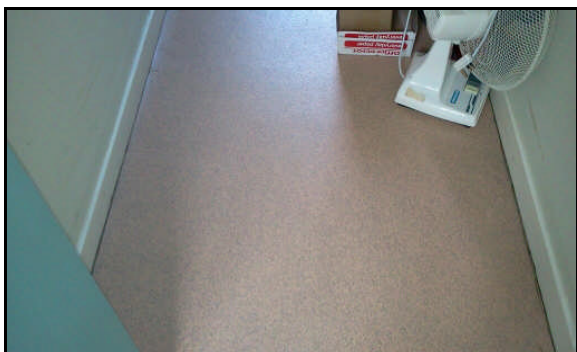
Building ID	Joint Valuation Board & Education Resource Centre	Item Description	Adhesive On Pink Vinyl Floor Covering
Sample No.	S0040	Material	Adhesive
Floor	Ground Floor	Asbestos Type	No Asbestos Detected
Room No.	43	Extent	-
Room ID	Vestibule	Notes:

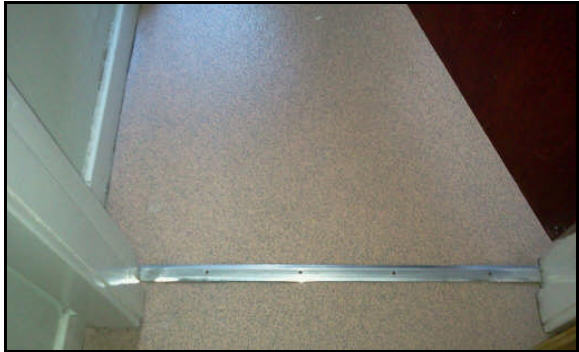
Building ID	Joint Valuation Board & Education Resource Centre	Item Description	Pink Vinyl Floor Covering
Sample No.	As S0039	Material	Vinyl Product
Floor	Ground Floor	Asbestos Type	No Asbestos Detected
Room No.	44	Extent	-
Room ID	Ladies Toilet	Notes:

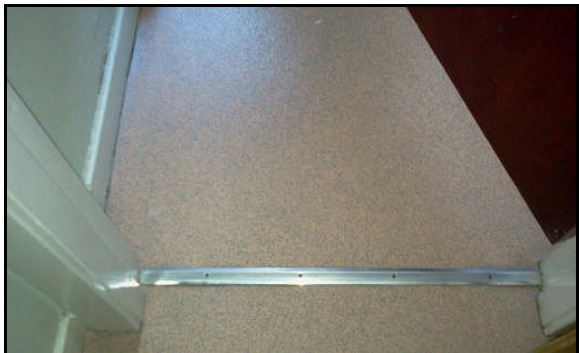
Building ID	Joint Valuation Board & Education Resource Centre	Item Description	Adhesive On Pink Vinyl Floor Covering
Sample No.	As S0040	Material	Adhesive
Floor	Ground Floor	Asbestos Type	No Asbestos Detected
Room No.	44	Extent	-
Room ID	Ladies Toilet	Notes:

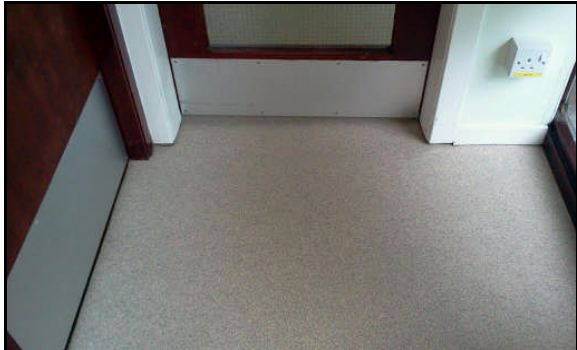
Building ID	Joint Valuation Board & Education Resource Centre	Item Description	Beige Vinyl Floor Covering
Sample No.	S0043	Material	Vinyl Product
Floor	Ground Floor	Asbestos Type	No Asbestos Detected
Room No.	45	Extent	-
Room ID	Corridor	Notes: No access was gained to the ceiling void due to fixed MMMF ceiling tiles, therefore asbestos is presumed to be present until proven otherwise.

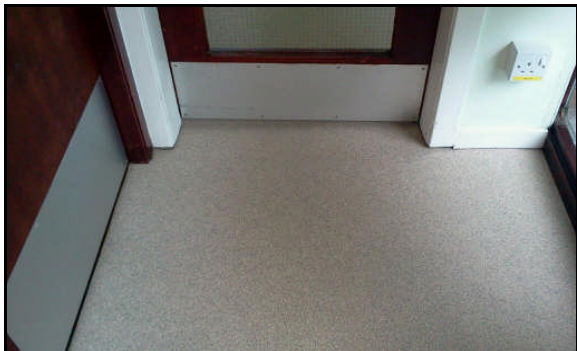
Building ID	Joint Valuation Board & Education Resource Centre	Item Description	Adhesive On Beige Vinyl Floor Covering
Sample No.	S0044	Material	Adhesive
Floor	Ground Floor	Asbestos Type	No Asbestos Detected
Room No.	45	Extent	-
Room ID	Corridor	Notes: No access was gained to the ceiling void due to fixed MMMF ceiling tiles, therefore asbestos is presumed to be present until proven otherwise.

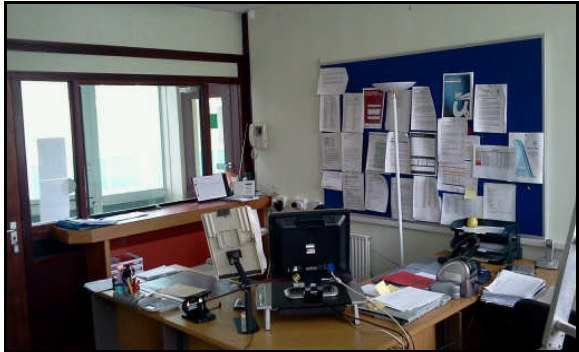
Building ID	Joint Valuation Board & Education Resource Centre	Item Description	No Suspect Materials Seen
Sample No.	-	Material	-
Floor	Ground Floor	Asbestos Type	-
Room No.	46	Extent	-
Room ID	Main Office	Notes: No access was gained below the fixed carpet due to the irreparable damage that would be caused, therefore it must be presumed to contain asbestos until proven otherwise.

Surveyor:	Donald Campbell
		Recommendation:	-

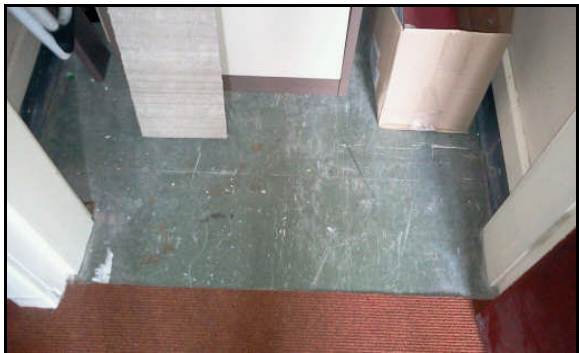
Building ID	Joint Valuation Board & Education Resource Centre	Item Description	Green Vinyl Tiles
Sample No.	S0045	Material	Vinyl Product
Floor	Ground Floor	Asbestos Type	No Asbestos Detected
Room No.	47	Extent	-
Room ID	Cupboard	Notes:

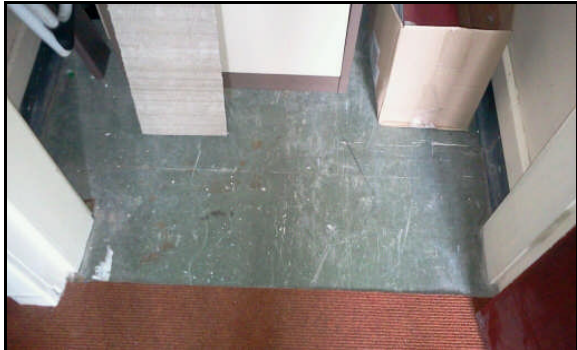
Building ID	Joint Valuation Board & Education Resource Centre	Item Description	Adhesive On Green Vinyl Tiles
Sample No.	S0046	Material	Adhesive
Floor	Ground Floor	Asbestos Type	No Asbestos Detected
Room No.	47	Extent	-
Room ID	Cupboard	Notes:

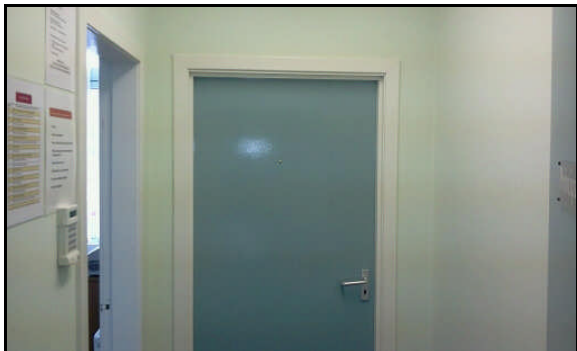
Building ID	Joint Valuation Board & Education Resource Centre	Item Description	No Suspect Materials Seen
Sample No.	-	Material	-
Floor	Ground Floor	Asbestos Type	-
Room No.	48	Extent	-
Room ID	Vestibule	Notes:

No access was gained below the fixed carpet due to the irreparable damage that would be caused, therefore it must be presumed to contain asbestos until proven otherwise.	
		No access was gained to the ceiling void due to fixed MMMF ceiling tiles, therefore asbestos is presumed to be present until proven otherwise.	
		Surveyor: Donald Campbell	
		Recommendation: -

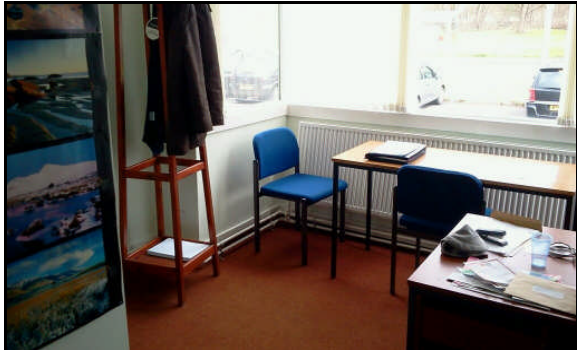
Building ID	Joint Valuation Board & Education Resource Centre	Item Description	No Suspect Materials Seen
Sample No.	-	Material	-
Floor	Ground Floor	Asbestos Type	-
Room No.	49	Extent	-
Room ID	Office	Notes: No access was gained below the fixed carpet due to the irreparable damage that would be caused, therefore it must be presumed to contain asbestos until proven otherwise. No access was gained to the ceiling void due to fixed MMMF ceiling tiles, therefore asbestos is presumed to be present until proven otherwise.

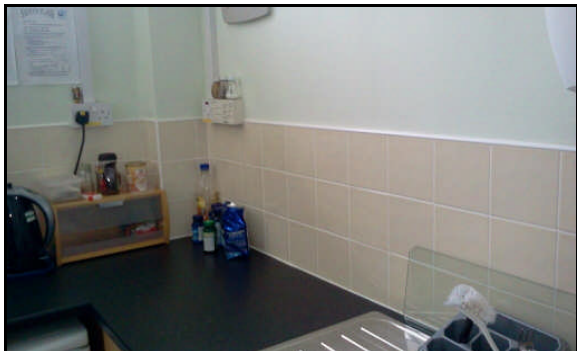
Building ID	Joint Valuation Board & Education Resource Centre	Item Description	Ceramic Tile Adhesive On Walls
Sample No.	S0047	Material	Adhesive
Floor	Ground Floor	Asbestos Type	No Asbestos Detected
Room No.	50	Extent	-
Room ID	Kitchen	Notes:

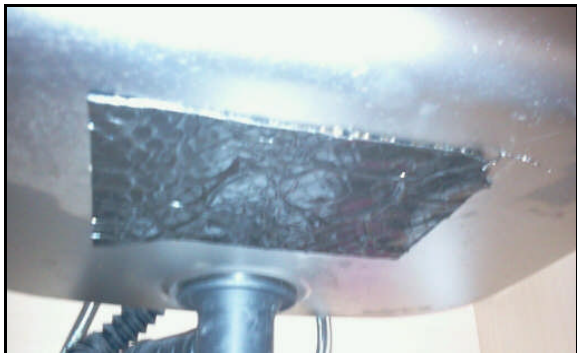
Building ID	Joint Valuation Board & Education Resource Centre	Item Description	Bitumen Sink Pad
Sample No.	S0048	Material	Bituminous Products
Floor	Ground Floor	Asbestos Type	No Asbestos Detected
Room No.	50	Extent	-
Room ID	Kitchen	Notes:

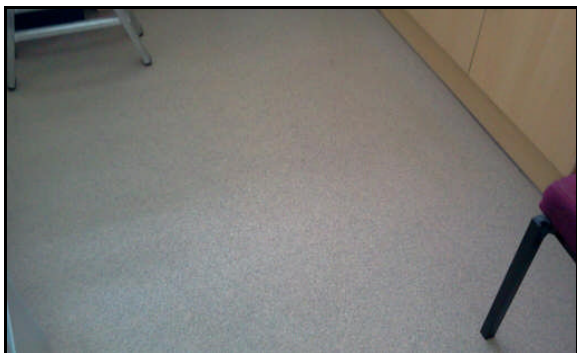
Building ID	Joint Valuation Board & Education Resource Centre	Item Description	Beige Vinyl Floor Covering
Sample No.	As S0043	Material	Vinyl Product
Floor	Ground Floor	Asbestos Type	No Asbestos Detected
Room No.	50	Extent	-
Room ID	Kitchen	Notes:

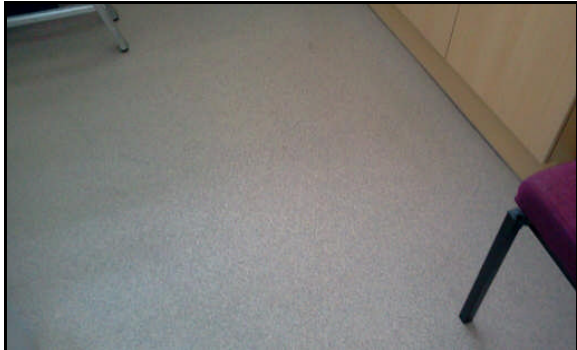
Building ID	Joint Valuation Board & Education Resource Centre	Item Description	Adhesive On Beige Vinyl Floor Covering
Sample No.	As S0044	Material	Adhesive
Floor	Ground Floor	Asbestos Type	No Asbestos Detected
Room No.	50	Extent	-
Room ID	Kitchen	Notes:

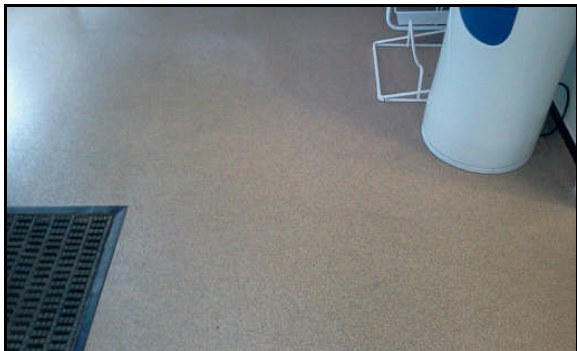
Building ID	Joint Valuation Board & Education Resource Centre	Item Description	Beige Vinyl Floor Covering
Sample No.	As S0043	Material	Vinyl Product
Floor	Ground Floor	Asbestos Type	No Asbestos Detected
Room No.	51	Extent	-
Room ID	Entrance Vestibule	Notes:

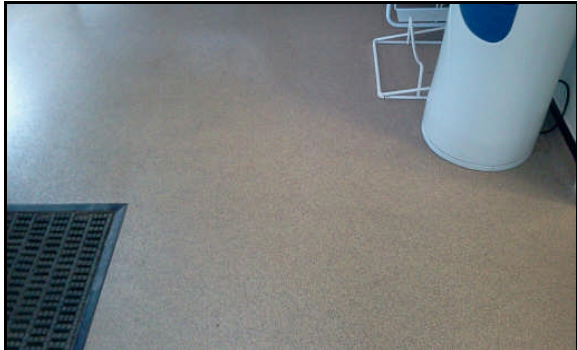
Building ID	Joint Valuation Board & Education Resource Centre	Item Description	Adhesive On Beige Vinyl Floor Covering
Sample No.	As S0044	Material	Adhesive
Floor	Ground Floor	Asbestos Type	No Asbestos Detected
Room No.	51	Extent	-
Room ID	Entrance Vestibule	Notes:

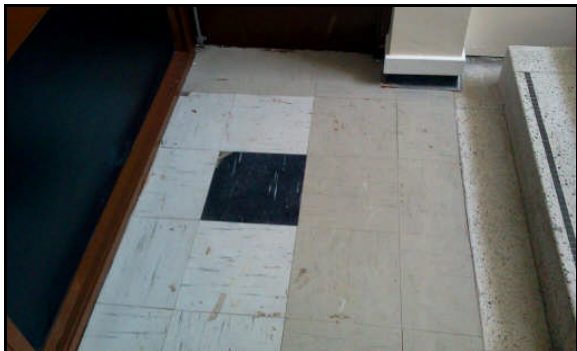
Building ID	Joint Valuation Board & Education Resource Centre	Item Description	Grey Vinyl Floor Tiles
Sample No.	S0049	Material	Vinyl Product
Floor	Ground Floor	Asbestos Type	No Asbestos Detected
Room No.	52	Extent	-
Room ID	Landing & Stairs	Notes:

No access was gained to the ceiling void due to fixed MMMF ceiling tiles, therefore asbestos must be presumed to be present until proven otherwise.	
		Surveyor: Donald Campbell	
		Recommendation: -

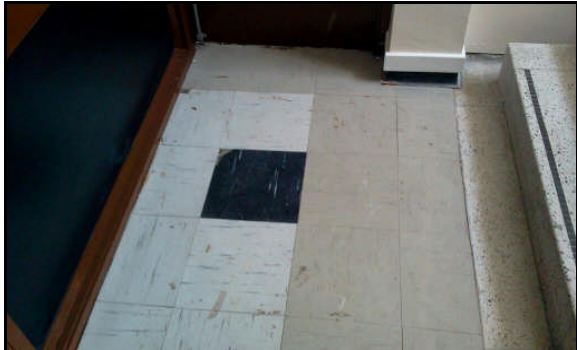
Building ID	Joint Valuation Board & Education Resource Centre	Item Description	Adhesive On Grey Vinyl Floor Tiles
Sample No.	S0050	Material	Adhesive
Floor	Ground Floor	Asbestos Type	Chrysotile
Room No.	52	Extent	1m ²
Room ID	Landing & Stairs	Notes: No access was gained to the ceiling void due to fixed MMMF ceiling tiles, therefore asbestos must be presumed to be present until proven otherwise.

HSG 264 Material Assessment Scores				Priority Assessment Scores			Risk Priority Rating:
Product:	1	Condition:	0	Occupant Activity:	1	Likelihood of Disturbance:	1
Surface Treatment:	0	Asbestos Type:	1	Potential of Human Exposure:	2	Maintenance Activity:	0
Material Score:	2	Material Category:	D	Priority Score:	4	Total Score (Overall):	6

Surveyor:	Donald Campbell
		Recommendation:	Manage

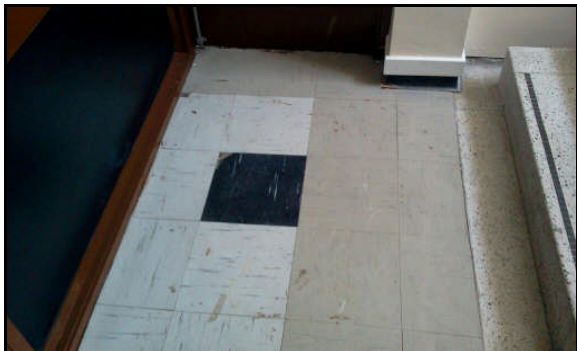
Building ID	Joint Valuation Board & Education Resource Centre	Item Description	White Vinyl Floor Tiles
Sample No.	S0051	Material	Vinyl Product
Floor	Ground Floor	Asbestos Type	Chrysotile
Room No.	52	Extent	1m ²
Room ID	Landing & Stairs	Notes: No access was gained to the ceiling void due to fixed MMMF ceiling tiles, therefore asbestos must be presumed to be present until proven otherwise.

HSG 264 Material Assessment Scores				Priority Assessment Scores			Risk Priority Rating:
Product:	1	Condition:	0	Occupant Activity:	1	Likelihood of Disturbance:	2
Surface Treatment:	0	Asbestos Type:	1	Potential of Human Exposure:	2	Maintenance Activity:	1
Material Score:	2	Material Category:	D	Priority Score:	6	Total Score (Overall):	8

Surveyor:	Donald Campbell
		Recommendation:	Manage

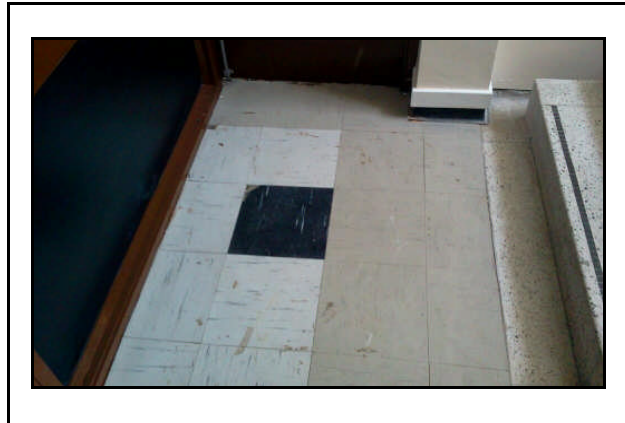
Notes:
No access was gained to the ceiling void due to fixed MMMF ceiling tiles, therefore asbestos must be presumed to be present until proven otherwise.

HSG 264 Material Assessment Scores				Priority Assessment Scores			Risk Priority Rating:
Product:	1	Condition:	0	Occupant Activity:	1	Likelihood of Disturbance:	1
Surface Treatment:	0	Asbestos Type:	1	Potential of Human Exposure:	2	Maintenance Activity:	0
Material Score:	2	Material Category:	D	Priority Score:	4	Total Score (Overall):	6

Surveyor:	Donald Campbell
Recommendation:	Manage

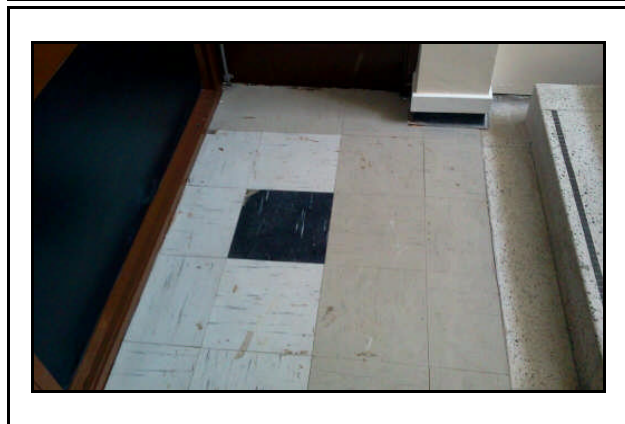
Notes:
No access was gained to the ceiling void due to fixed MMMF ceiling tiles, therefore asbestos must be presumed to be present until proven otherwise.

Surveyor:	Donald Campbell
Recommendation:	Manage

HSG 264 Material Assessment Scores				Priority Assessment Scores			Risk Priority Rating:
Product:	1	Condition:	0	Occupant Activity:	1	Likelihood of Disturbance:	2
Surface Treatment:	0	Asbestos Type:	1	Potential of Human Exposure:	2	Maintenance Activity:	1
Material Score:	2	Material Category:	D	Priority Score:	6	Total Score (Overall):	8

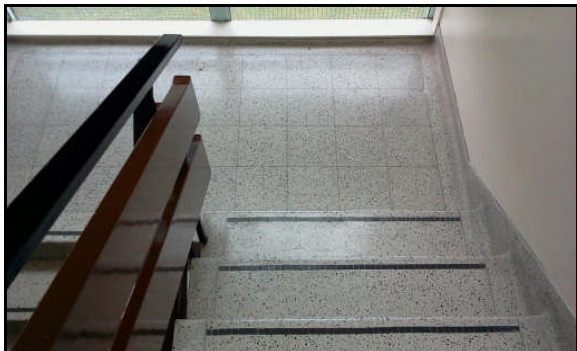
Building ID	Joint Valuation Board & Education Resource Centre	Item Description	Composite Flooring
Sample No.	As S0001	Material	Composite Flooring
Floor	Ground Floor	Asbestos Type	No Asbestos Detected
Room No.	52	Extent	-
Room ID	Landing & Stairs	Notes: No access was gained to the ceiling void due to fixed MMMF ceiling tiles, therefore asbestos must be presumed to be present until proven otherwise.

Surveyor:	Donald Campbell
		Recommendation:	-

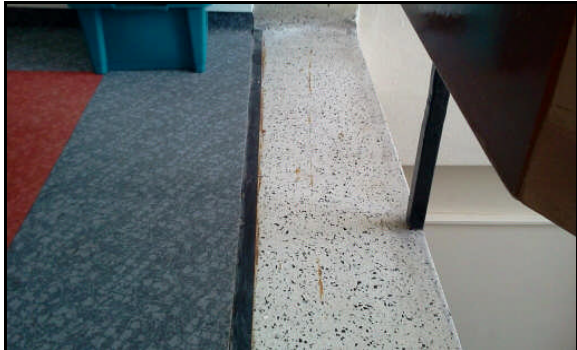
Building ID	Joint Valuation Board & Education Resource Centre	Item Description	Composite Flooring
Sample No.	As S0001	Material	Composite Flooring
Floor	First Floor	Asbestos Type	No Asbestos Detected
Room No.	53	Extent	-
Room ID	Landing & Corridor	Notes: No access was gained below the fixed carpet due to the irreparable damage that would be caused, therefore it must be presumed to contain asbestos until proven otherwise. No access was gained to the ceiling void due to fixed MMMF ceiling tiles, therefore asbestos is presumed to be present until proven otherwise. No access was gained within the live electrics for safety reasons, therefore asbestos is presumed to be present until proven otherwise.

Surveyor:	Donald Campbell
		Recommendation:	-
