Asbestos Management Survey
At
**Joint Valuation Board and Education Resource Centre,
235 Dumbarton Road, Clydebank**

Customer: West Dunbartonshire Council

Project No: G13-00301

Report Issue Date: 14 June 2013

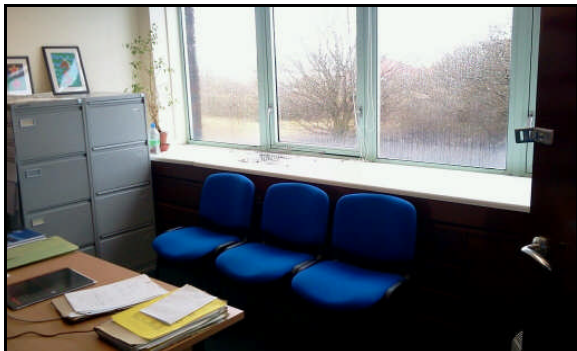
Building ID	Joint Valuation Board & Education Resource Centre	Item Description	No Suspect Materials Seen
Sample No.	-	Material	-
Floor	First Floor	Asbestos Type	-
Room No.	54	Extent	-
Room ID	Office	Notes: No access was gained below the fixed carpet due to the irreparable damage that would be caused, therefore it must be presumed to contain asbestos until proven otherwise. No access was gained to the ceiling void due to fixed MMMF ceiling tiles, therefore asbestos is presumed to be present until proven otherwise.

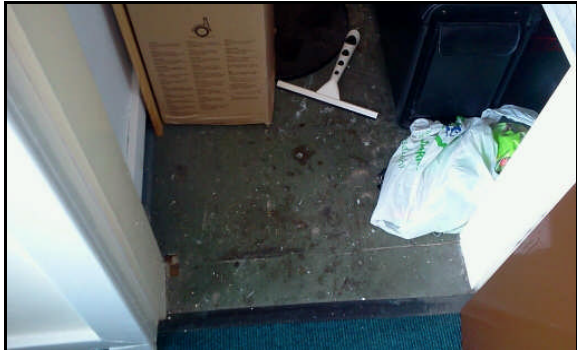
Building ID	Joint Valuation Board & Education Resource Centre	Item Description	Green Vinyl Floor Tiles
Sample No.	S0055	Material	Vinyl Product
Floor	First Floor	Asbestos Type	No Asbestos Detected
Room No.	55	Extent	-
Room ID	Cupboard	Notes:

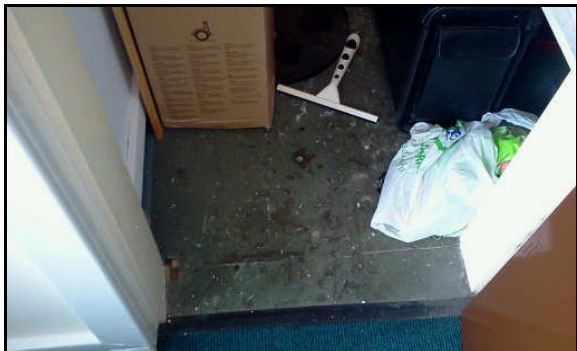
Building ID	Joint Valuation Board & Education Resource Centre	Item Description	Adhesive On Green Vinyl Floor Tiles
Sample No.	S0056	Material	Adhesive
Floor	First Floor	Asbestos Type	No Asbestos Detected
Room No.	55	Extent	-
Room ID	Cupboard	Notes:

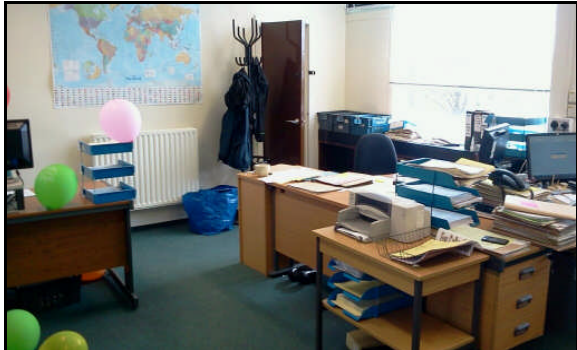
Building ID	Joint Valuation Board & Education Resource Centre	Item Description	No Suspect Materials Seen
Sample No.	-	Material	-
Floor	First Floor	Asbestos Type	-
Room No.	56	Extent	-
Room ID	Office	Notes: No access was gained below the fixed carpet due to the irreparable damage that would be caused, therefore it must be presumed to contain asbestos until proven otherwise.

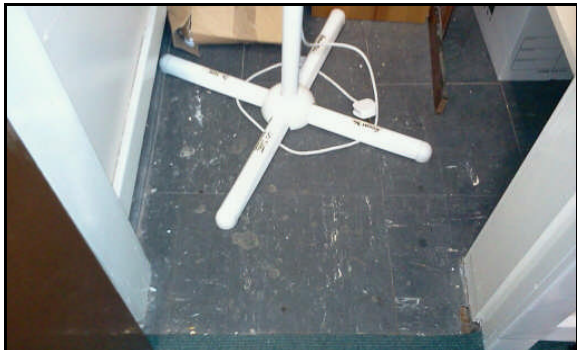
Building ID	Joint Valuation Board & Education Resource Centre	Item Description	Black Vinyl Floor Tiles
Sample No.	S0057	Material	Vinyl Product
Floor	First Floor	Asbestos Type	No Asbestos Detected
Room No.	57	Extent	-
Room ID	Cupboard	Notes:

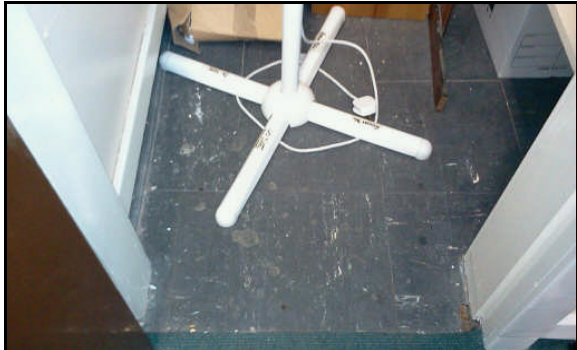
Building ID	Joint Valuation Board & Education Resource Centre	Item Description	Adhesive On Black Vinyl Floor Tiles
Sample No.	S0058	Material	Adhesive
Floor	First Floor	Asbestos Type	No Asbestos Detected
Room No.	57	Extent	-
Room ID	Cupboard	Notes:

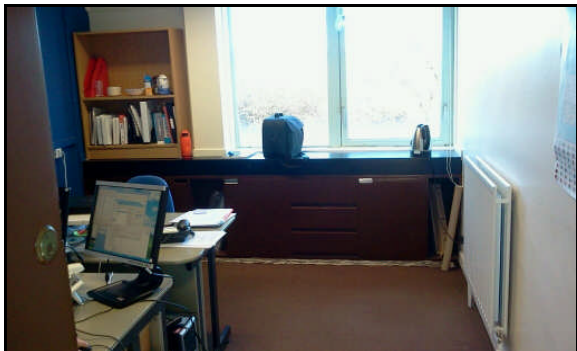
Building ID	Joint Valuation Board & Education Resource Centre	Item Description	No Suspect Materials Seen
Sample No.	-	Material	-
Floor	First Floor	Asbestos Type	-
Room No.	58	Extent	-
Room ID	Office	Notes:

No access was gained below the fixed carpet due to the irreparable damage that would be caused, therefore it must be presumed to contain asbestos until proven otherwise.	
		No access was gained to the ceiling void due to fixed ceiling tiles, therefore asbestos is presumed to be present until proven otherwise.	
		Surveyor:	Donald Campbell
		Recommendation:	-

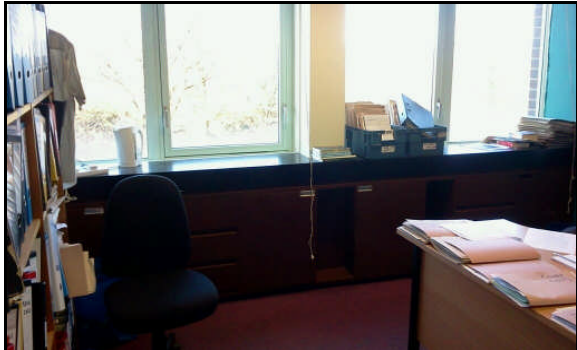
Building ID	Joint Valuation Board & Education Resource Centre	Item Description	No Suspect Materials Seen
Sample No.	-	Material	-
Floor	First Floor	Asbestos Type	-
Room No.	59	Extent	-
Room ID	Office	Notes: No access was gained below the fixed carpet due to the irreparable damage that would be caused, therefore it must be presumed to contain asbestos until proven otherwise. No access was gained to the ceiling void due to fixed ceiling tiles, therefore asbestos is presumed to be present until proven otherwise.

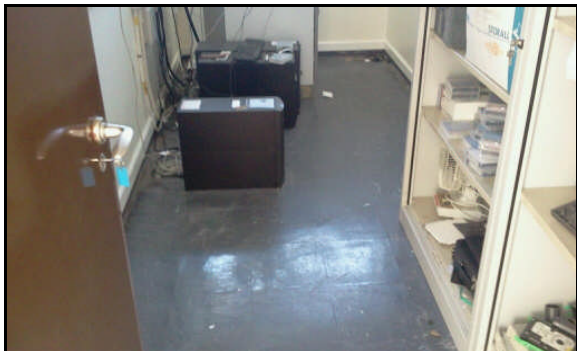
Building ID	Joint Valuation Board & Education Resource Centre	Item Description	Grey Vinyl Floor Covering
Sample No.	S0059	Material	Vinyl Product
Floor	First Floor	Asbestos Type	No Asbestos Detected
Room No.	60	Extent	-
Room ID	Server Room	Notes: No access was gained to the ceiling void due to fixed ceiling tiles, therefore asbestos is presumed to be present until proven otherwise.

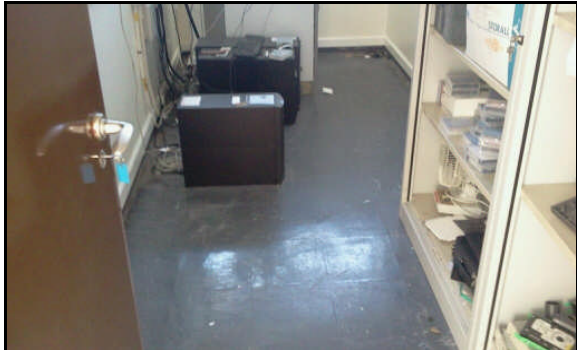
Building ID	Joint Valuation Board & Education Resource Centre	Item Description	Adhesive On Grey Vinyl Floor Covering
Sample No.	S0060	Material	Adhesive
Floor	First Floor	Asbestos Type	No Asbestos Detected
Room No.	60	Extent	-
Room ID	Server Room	Notes: No access was gained to the ceiling void due to fixed ceiling tiles, therefore asbestos is presumed to be present until proven otherwise

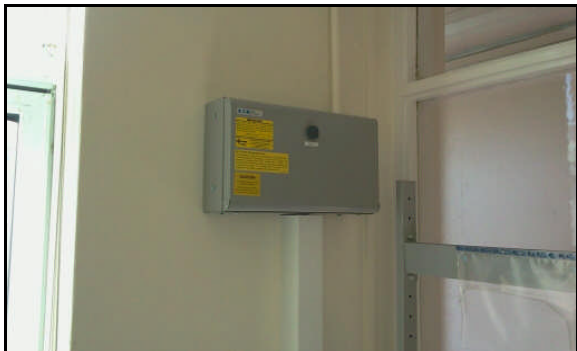
Building ID	Joint Valuation Board & Education Resource Centre	Item Description	No Suspect Materials Seen
Sample No.	-	Material	-
Floor	First Floor	Asbestos Type	-
Room No.	61	Extent	-
Room ID	Copy Room	Notes: No access was gained below the fixed carpet due to the irreparable damage that would be caused, therefore it must be presumed to contain asbestos until proven otherwise. No access was gained to the ceiling void due to fixed ceiling tiles, therefore asbestos is presumed to be present until proven otherwise. No access was gained within the live electrics for safety reasons, therefore asbestos is presumed to be present until proven otherwise.

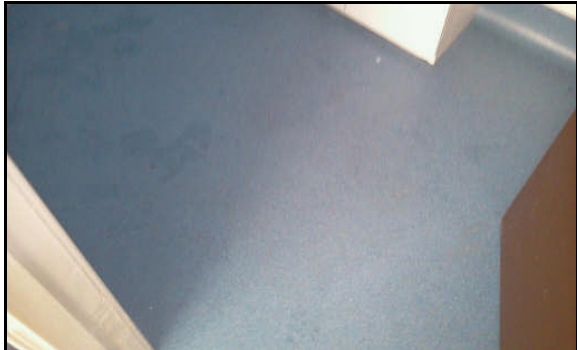
Building ID	Joint Valuation Board & Education Resource Centre	Item Description	Blue Vinyl Floor Covering
Sample No.	S0061	Material	Vinyl Product
Floor	First Floor	Asbestos Type	No Asbestos Detected
Room No.	62	Extent	-
Room ID	Shower Room	Notes: No access was gained within the ceiling void due to fixed ceiling tiles, therefore asbestos is presumed to be present until proven otherwise.

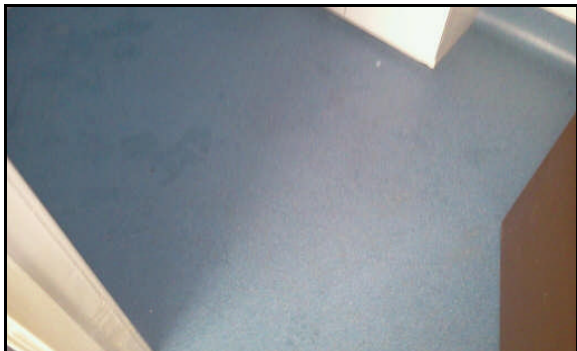
Building ID	Joint Valuation Board & Education Resource Centre	Item Description	Adhesive On Blue Vinyl Floor Covering
Sample No.	S0062	Material	Adhesive
Floor	First Floor	Asbestos Type	No Asbestos Detected
Room No.	62	Extent	-
Room ID	Shower Room	Notes: No access was gained within the ceiling void due to fixed ceiling tiles, therefore asbestos is presumed to be present until proven otherwise.

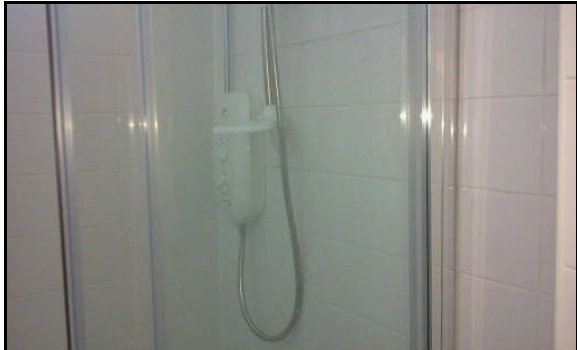
Building ID	Joint Valuation Board & Education Resource Centre	Item Description	Ceramic Tile Adhesive On Walls
Sample No.	S0063	Material	Adhesive
Floor	First Floor	Asbestos Type	No Asbestos Detected
Room No.	62	Extent	-
Room ID	Shower Room	Notes: No access was gained within the ceiling void due to fixed ceiling tiles, therefore asbestos is presumed to be present until proven otherwise.

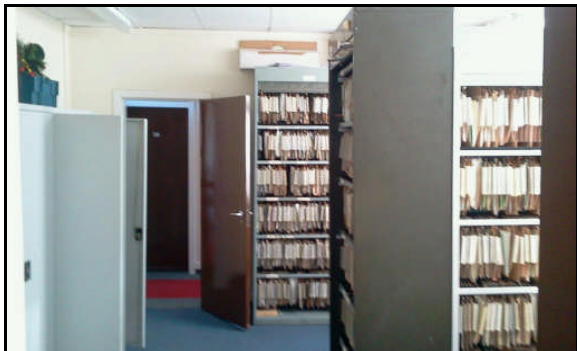
Building ID	Joint Valuation Board & Education Resource Centre	Item Description	No Suspect Materials Seen
Sample No.	-	Material	-
Floor	First Floor	Asbestos Type	-
Room No.	63	Extent	-
Room ID	File Room	Notes: No access was gained below the fixed carpet due to the irreparable damage that would be caused, therefore it must be presumed to contain asbestos until proven otherwise.

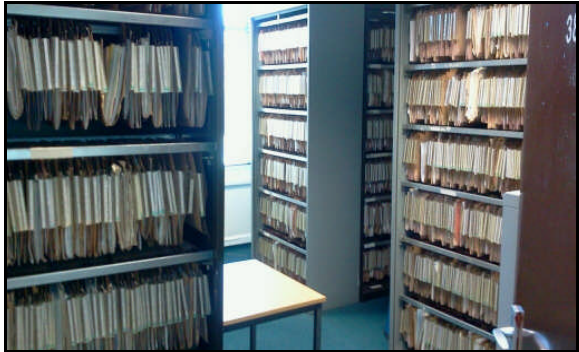
Building ID	Joint Valuation Board & Education Resource Centre	Item Description	No Suspect Materials Seen
Sample No.	-	Material	-
Floor	First Floor	Asbestos Type	-
Room No.	64	Extent	-
Room ID	File Room	Notes: No access was gained below the fixed carpet due to the irreparable damage that would be caused, therefore it must be presumed to contain asbestos until proven otherwise. No access was gained to the ceiling void due to fixed ceiling tiles, therefore asbestos is presumed to be present until proven otherwise.

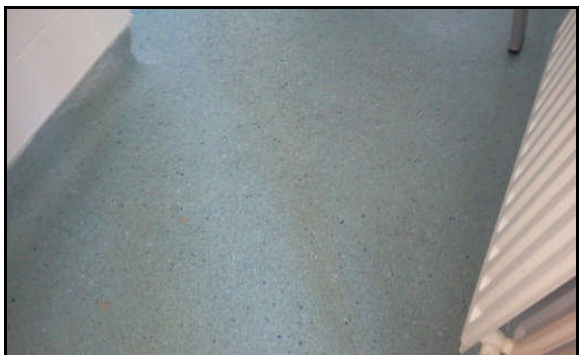
Building ID	Joint Valuation Board & Education Resource Centre	Item Description	Green Vinyl Floor Covering
Sample No.	S0064	Material	Vinyl Product
Floor	First Floor	Asbestos Type	No Asbestos Detected
Room No.	65	Extent	-
Room ID	Ladies Toilet	Notes:

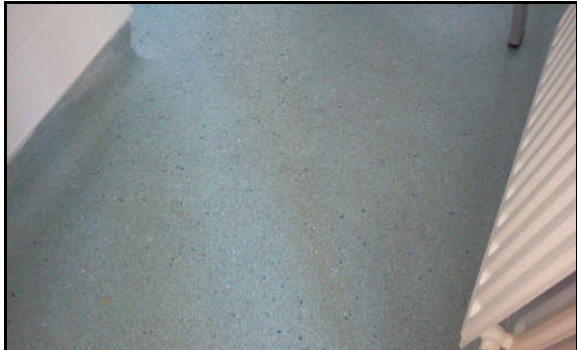
Building ID	Joint Valuation Board & Education Resource Centre	Item Description	Adhesive On Green Vinyl Floor Covering
Sample No.	S0065	Material	Adhesive
Floor	First Floor	Asbestos Type	No Asbestos Detected
Room No.	65	Extent	-
Room ID	Ladies Toilet	Notes:

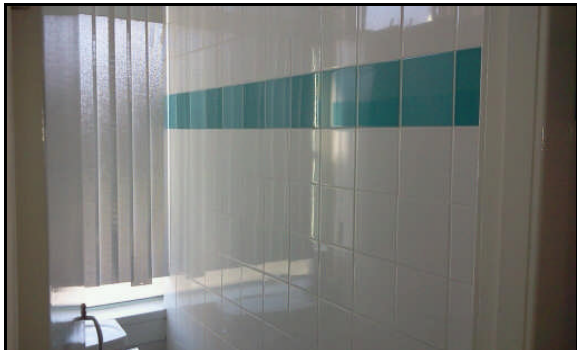
Building ID	Joint Valuation Board & Education Resource Centre	Item Description	Ceramic Tile Adhesive On Walls
Sample No.	S0066	Material	Adhesive
Floor	First Floor	Asbestos Type	No Asbestos Detected
Room No.	65	Extent	-
Room ID	Ladies Toilet	Notes:

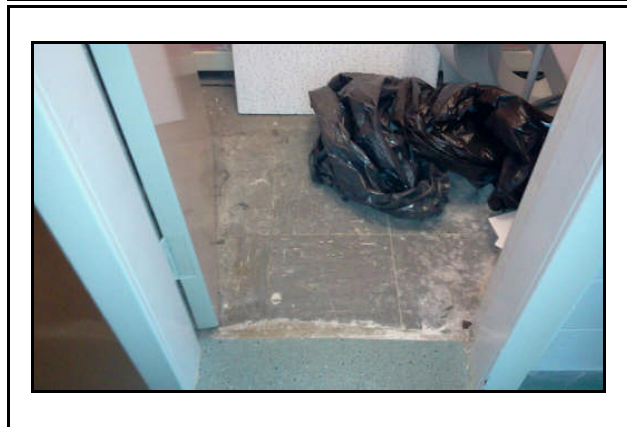
Notes:
No access was gained within the ceramic tile clad timber boxing on walls 3 & 4 due to the irreparable damage that would be caused, therefore asbestos must be presumed to be present until proven otherwise.

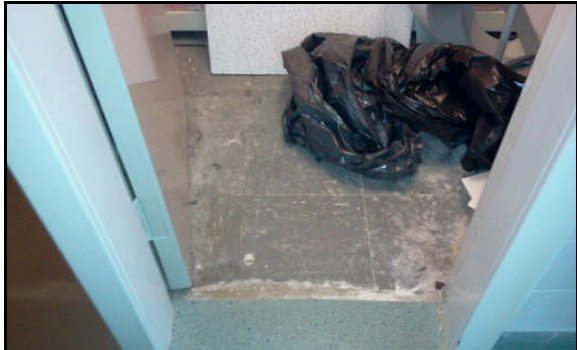
Building ID	Joint Valuation Board & Education Resource Centre	Item Description	Adhesive On Grey Vinyl Floor Tiles
Sample No.	S0069	Material	Adhesive
Floor	First Floor	Asbestos Type	No Asbestos Detected
Room No.	66	Extent	-
Room ID	Cleaner's Cupboard	Notes: No access was gained within the ceramic tile clad timber boxing on walls 3 & 4 due to the irreparable damage that would be caused, therefore asbestos must be presumed to be present until proven otherwise.

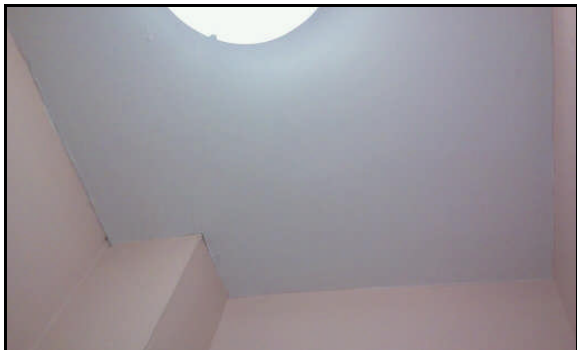
Building ID	Joint Valuation Board & Education Resource Centre	Item Description	Insulating Board Panels On Ceiling
Sample No.	S0070	Material	Insulating Board
Floor	First Floor	Asbestos Type	No Asbestos Detected
Room No.	66	Extent	-
Room ID	Cleaner's Cupboard	Notes: No access was gained within the ceramic tile clad timber boxing on walls 3 & 4 due to the irreparable damage that would be caused, therefore asbestos must be presumed to be present until proven otherwise.

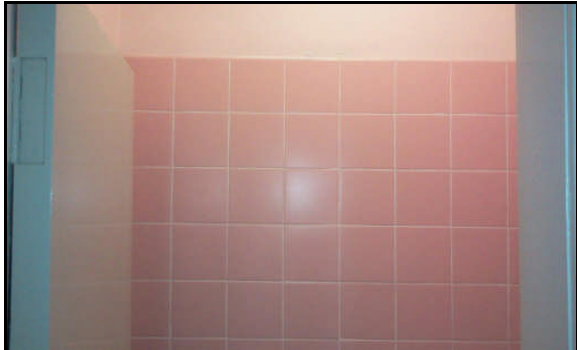
Building ID	Joint Valuation Board & Education Resource Centre	Item Description	Ceramic Tile Adhesive On Walls
Sample No.	S0071	Material	Adhesive
Floor	First Floor	Asbestos Type	No Asbestos Detected
Room No.	66	Extent	-
Room ID	Cleaner's Cupboard	Notes: No access was gained within the ceramic tile clad timber boxing on walls 3 & 4 due to the irreparable damage that would be caused, therefore asbestos must be presumed to be present until proven otherwise.

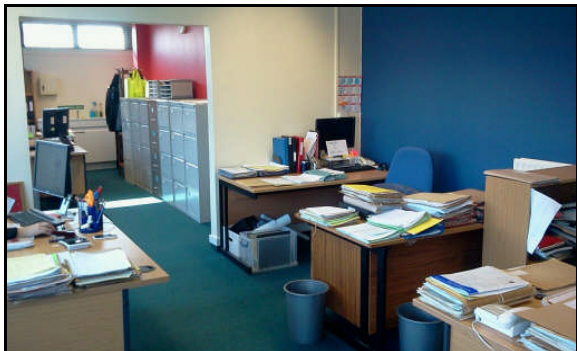
Building ID	Joint Valuation Board & Education Resource Centre	Item Description	No Suspect Materials Seen
Sample No.	-	Material	-
Floor	First Floor	Asbestos Type	-
Room No.	67	Extent	-
Room ID	Office	Notes: No access was gained below the fixed carpet due to the irreparable damage that would be caused, therefore it must be presumed to contain asbestos until proven otherwise. No access was gained to the ceiling void due to fixed ceiling tiles, therefore asbestos is presumed to be present until proven otherwise. No access was gained within the timber risers on walls 3 & 7 due to the irreparable damage that would be caused, therefore asbestos is presumed to be present until proven otherwise.

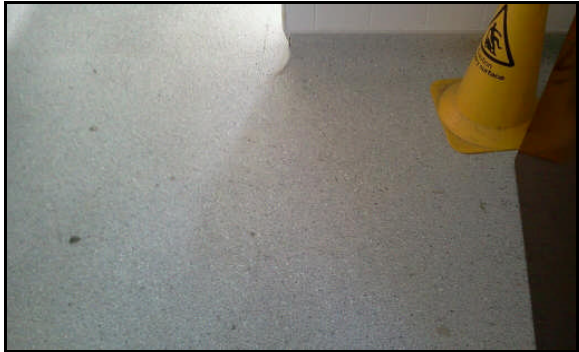
Building ID	Joint Valuation Board & Education Resource Centre	Item Description	Grey Vinyl Floor Covering
Sample No.	S0072	Material	Vinyl Product
Floor	First Floor	Asbestos Type	No Asbestos Detected
Room No.	68	Extent	-
Room ID	Gents Toilet	Notes: No access was gained within the ceramic tile clad riser on walls 4 & 5 due to the irreparable damage that would be caused, therefore asbestos is presumed to be present until proven otherwise.

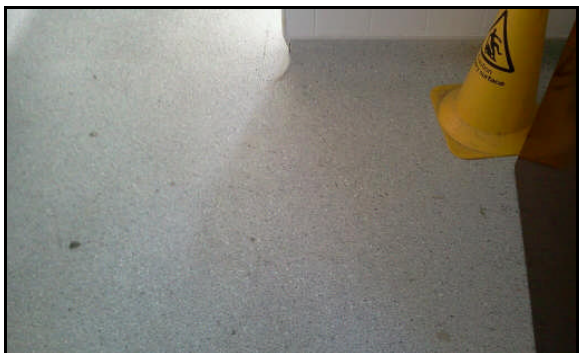
Building ID	Joint Valuation Board & Education Resource Centre	Item Description	Adhesive On Grey Vinyl Floor Covering
Sample No.	S0073	Material	Adhesive
Floor	First Floor	Asbestos Type	No Asbestos Detected
Room No.	68	Extent	-
Room ID	Gents Toilet	Notes: No access was gained within the ceramic tile clad riser on walls 4 & 5 due to the irreparable damage that would be caused, therefore asbestos is presumed to be present until proven otherwise.

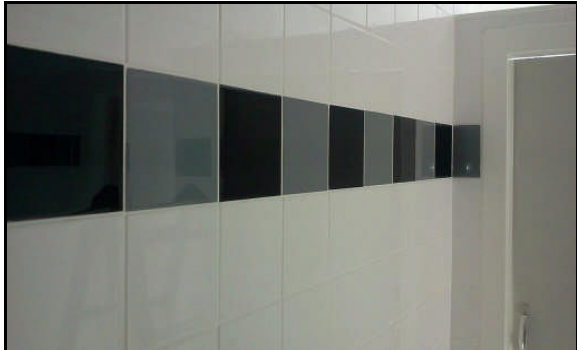
Building ID	Joint Valuation Board & Education Resource Centre	Item Description	Ceramic Tile Adhesive On Walls
Sample No.	S0076	Material	Adhesive
Floor	First Floor	Asbestos Type	No Asbestos Detected
Room No.	68	Extent	-
Room ID	Gents Toilet	Notes: No access was gained within the ceramic tile clad riser on walls 4 & 5 due to the irreparable damage that would be caused, therefore asbestos is presumed to be present until proven otherwise.

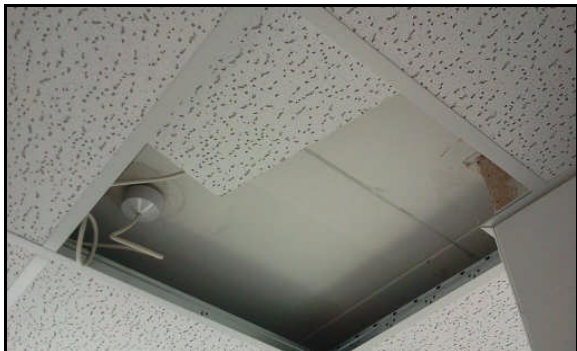
Building ID	Joint Valuation Board & Education Resource Centre	Item Description	Insulating Board Tiles Within Ceiling Void
Sample No.	S0077	Material	Insulating Board
Floor	First Floor	Asbestos Type	No Asbestos Detected
Room No.	68	Extent	-
Room ID	Gents Toilet	Notes: No access was gained within the ceramic tile clad riser on walls 4 & 5 due to the irreparable damage that would be caused, therefore asbestos is presumed to be present until proven otherwise.

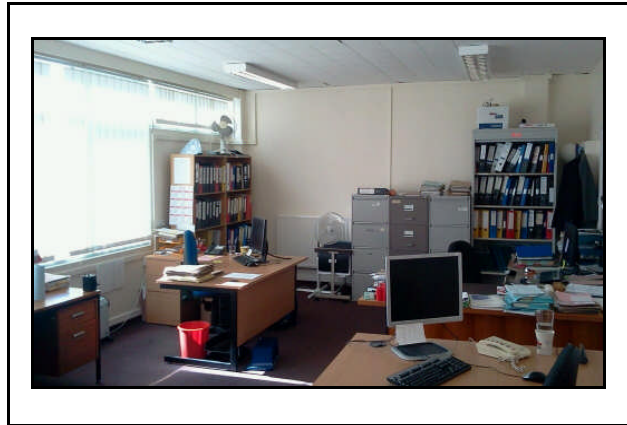
Notes:
 No access was gained below the fixed carpet due to the irreparable damage that would be caused, therefore it must be presumed to contain asbestos until proven otherwise.

No access was gained to the ceiling void due to fixed ceiling tiles, therefore asbestos is presumed to be present until proven otherwise.

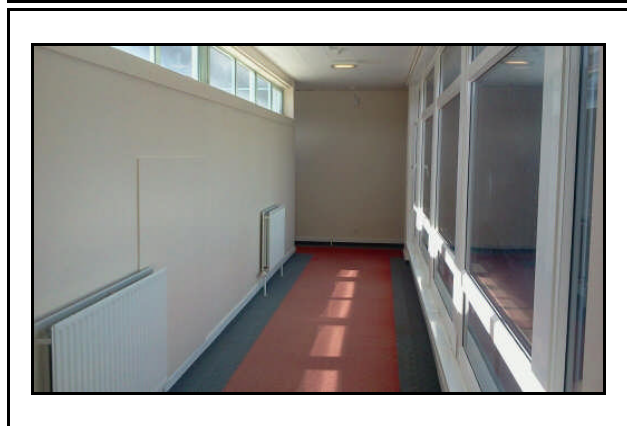
Notes:
 No access was gained below the fixed carpet due to the irreparable damage that would be caused, therefore it must be presumed to contain asbestos until proven otherwise.

No access was gained within the plasterboard boxing adjacent to Location 24 due to the irreparable damage that would be caused, therefore asbestos is presumed to be present until proven otherwise.

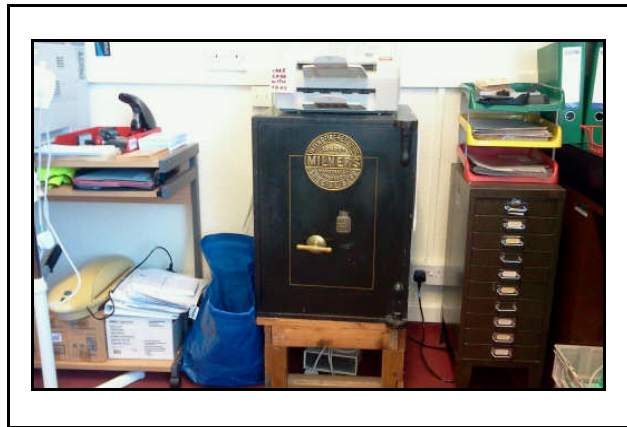
Notes:
 No access was gained below the fixed carpet due to the irreparable damage that would be caused, therefore it must be presumed to contain asbestos until proven otherwise.
 No access was gained to the ceiling void due to fixed ceiling tiles, therefore asbestos is presumed to be present until proven otherwise.
 No access was gained within the locked safe as no keys were available, therefore it is presumed to contain asbestos until proven otherwise.

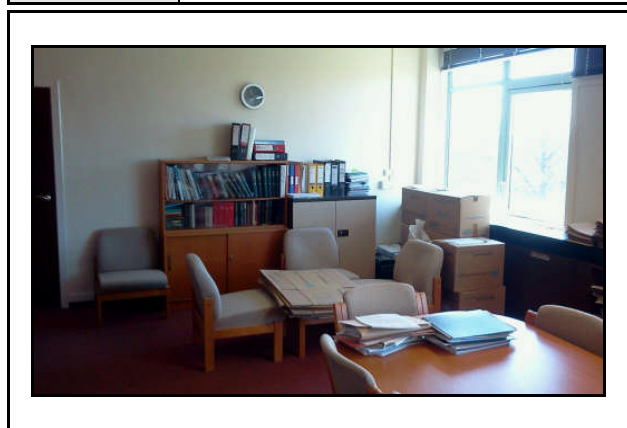
Notes:
 No access was gained below the fixed carpet due to the irreparable damage that would be caused, therefore it must be presumed to contain asbestos until proven otherwise.
 No access was gained to the ceiling void due to fixed ceiling tiles, therefore asbestos is presumed to be present until proven otherwise.

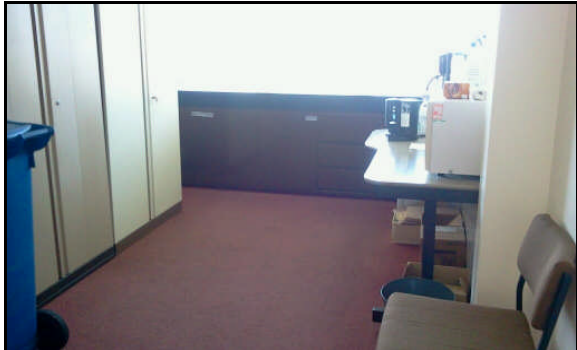
Building ID	Joint Valuation Board & Education Resource Centre	Item Description	No Suspect Materials Seen
Sample No.	-	Material	-
Floor	First Floor	Asbestos Type	-
Room No.	73	Extent	-
Room ID	Break Room	Notes: No access was gained below the fixed carpet due to the irreparable damage that would be caused, therefore it must be presumed to contain asbestos until proven otherwise. No access was gained to the ceiling void due to fixed ceiling tiles, therefore asbestos is presumed to be present until proven otherwise. No access was gained within the timber boxing on wall 4 as access would have caused irreparable damage, therefore it is presumed to contain asbestos until proven otherwise.

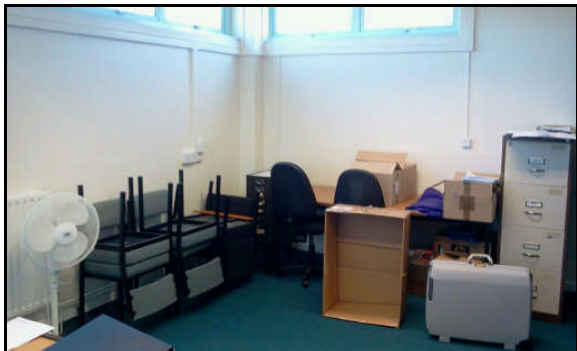
Building ID	Joint Valuation Board & Education Resource Centre	Item Description	No Suspect Materials Seen
Sample No.	-	Material	-
Floor	First Floor	Asbestos Type	-
Room No.	74	Extent	-
Room ID	Office	Notes: No access was gained below the fixed carpet due to the irreparable damage that would be caused, therefore it must be presumed to contain asbestos until proven otherwise. No access was gained to the ceiling void due to fixed ceiling tiles, therefore asbestos is presumed to be present until proven otherwise. No access was gained within the timber riser on walls 1 & 4 as access would have caused irreparable damage, therefore it is presumed to contain asbestos until proven otherwise.

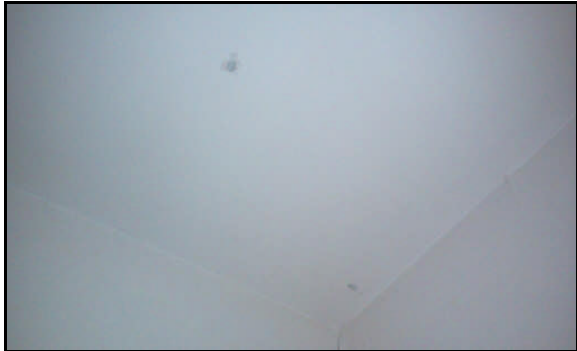
Building ID	Joint Valuation Board & Education Resource Centre	Item Description	Insulating Board Panels On Ceiling
Sample No.	S0078	Material	Insulating Board
Floor	First Floor	Asbestos Type	No Asbestos Detected
Room No.	75	Extent	-
Room ID	Cupboard	Notes:

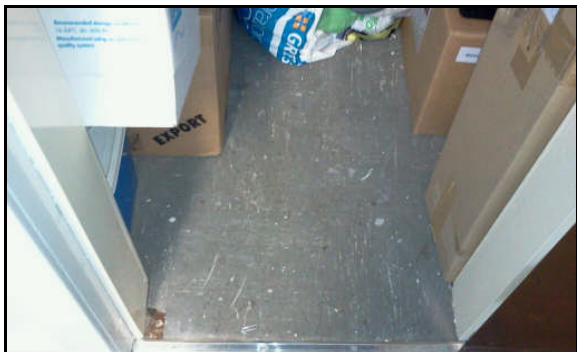
Building ID	Joint Valuation Board & Education Resource Centre	Item Description	Grey Vinyl Floor Tiles
Sample No.	S0079	Material	Vinyl Product
Floor	First Floor	Asbestos Type	No Asbestos Detected
Room No.	75	Extent	-
Room ID	Cupboard	Notes:

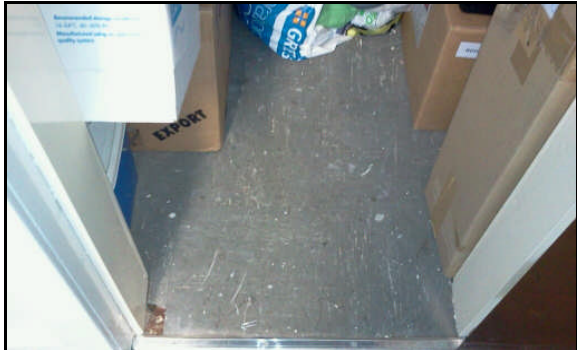
Building ID	Joint Valuation Board & Education Resource Centre	Item Description	Adhesive On Grey Vinyl Floor Tiles
Sample No.	S0080	Material	Adhesive
Floor	First Floor	Asbestos Type	No Asbestos Detected
Room No.	75	Extent	-
Room ID	Cupboard	Notes:

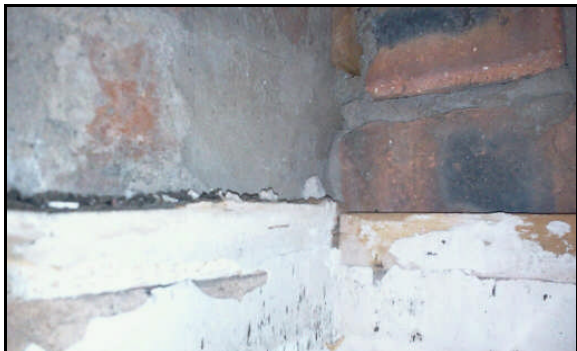
Building ID	Joint Valuation Board & Education Resource Centre	Item Description	Insulating Board Remnants On Redundant Timber Frame
Sample No.	S0081	Material	Insulating Board
Floor	First Floor	Asbestos Type	No Asbestos Detected
Room No.	76	Extent	-
Room ID	Toilet	Notes:

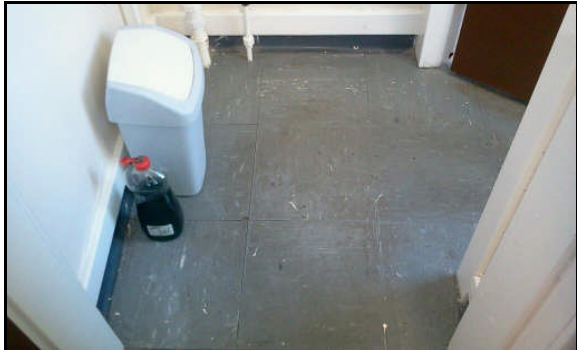
Building ID	Joint Valuation Board & Education Resource Centre	Item Description	Grey Vinyl Floor Tiles
Sample No.	As S0079	Material	Vinyl Product
Floor	First Floor	Asbestos Type	No Asbestos Detected
Room No.	76	Extent	-
Room ID	Toilet	Notes:

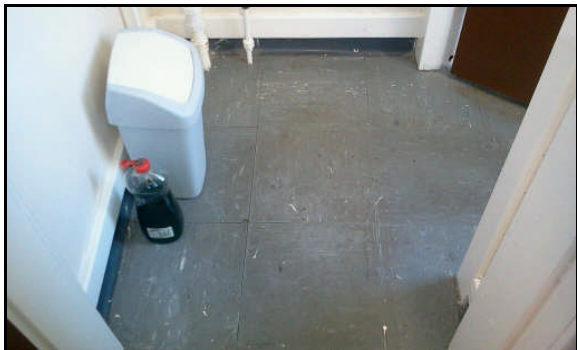
Building ID	Joint Valuation Board & Education Resource Centre	Item Description	Adhesive On Grey Vinyl Floor Tiles
Sample No.	As S0080	Material	Adhesive
Floor	First Floor	Asbestos Type	No Asbestos Detected
Room No.	76	Extent	-
Room ID	Toilet	Notes:

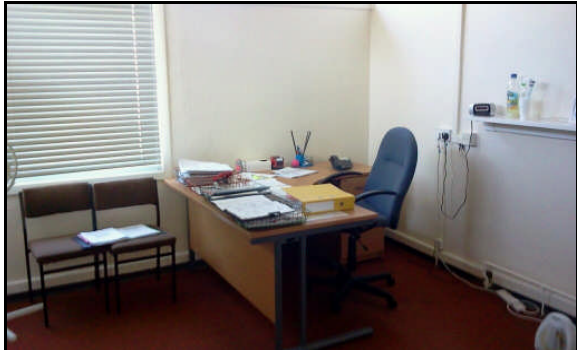
Building ID	Joint Valuation Board & Education Resource Centre	Item Description	No Suspect Materials Seen
Sample No.	-	Material	-
Floor	First Floor	Asbestos Type	-
Room No.	77	Extent	-
Room ID	Office	Notes: No access was gained below the fixed carpet due to the irreparable damage that would be caused, therefore it must be presumed to contain asbestos until proven otherwise. No access was gained to the ceiling void due to fixed ceiling tiles, therefore asbestos is presumed to be present until proven otherwise. No access was gained within the wall-papered timber riser on walls 1 & 2 as access would have caused irreparable damage, therefore it is presumed to contain asbestos until proven otherwise.

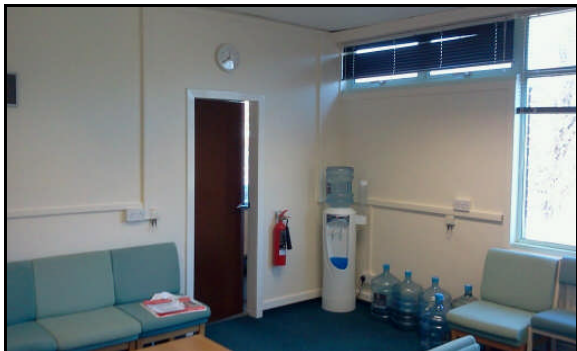
Building ID	Joint Valuation Board & Education Resource Centre	Item Description	No Suspect Materials Seen
Sample No.	-	Material	-
Floor	First Floor	Asbestos Type	-
Room No.	78	Extent	-
Room ID	Staff Room	Notes: No access was gained below the fixed carpet due to the irreparable damage that would be caused, therefore it must be presumed to contain asbestos until proven otherwise.

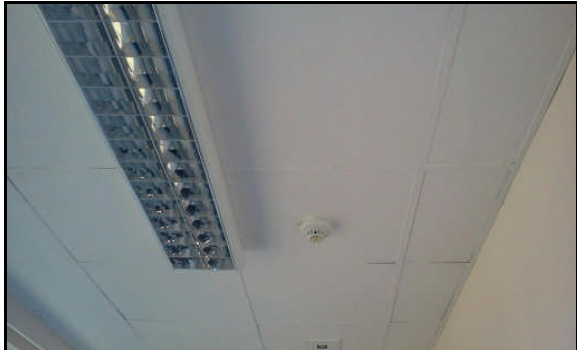
Building ID	Joint Valuation Board & Education Resource Centre	Item Description	Insulating Board Ceiling Tiles
Sample No.	S0082	Material	Insulating Board
Floor	First Floor	Asbestos Type	No Asbestos Detected
Room No.	79	Extent	-
Room ID	Kitchen	Notes: No access was gained within the timber riser on walls 3 & 4 as access would have caused irreparable damage, therefore it is presumed to contain asbestos until proven otherwise.

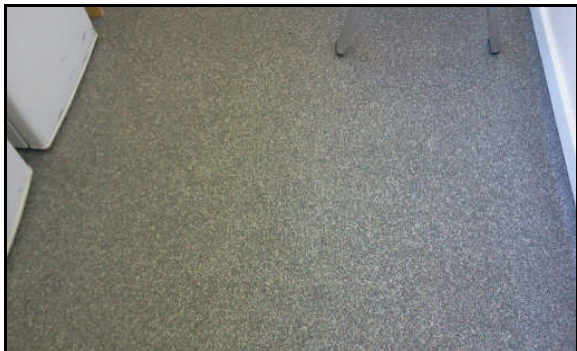
Building ID	Joint Valuation Board & Education Resource Centre	Item Description	Grey Vinyl Floor Covering
Sample No.	S0083	Material	Vinyl Product
Floor	First Floor	Asbestos Type	No Asbestos Detected
Room No.	79	Extent	-
Room ID	Kitchen	Notes: No access was gained within the timber riser on walls 3 & 4 as access would have caused irreparable damage, therefore it is presumed to contain asbestos until proven otherwise.

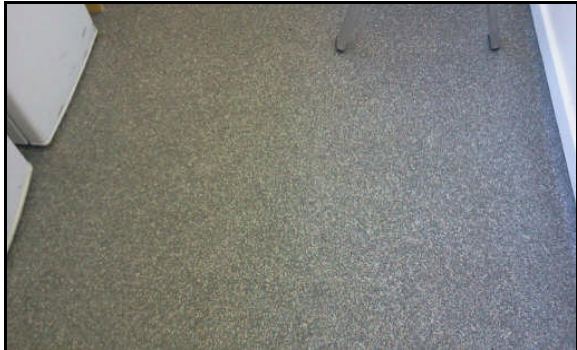
Building ID	Joint Valuation Board & Education Resource Centre	Item Description	Adhesive On Grey Vinyl Floor Covering
Sample No.	S0084	Material	Adhesive
Floor	First Floor	Asbestos Type	No Asbestos Detected
Room No.	79	Extent	-
Room ID	Kitchen	Notes: No access was gained within the timber riser on walls 3 & 4 as access would have caused irreparable damage, therefore it is presumed to contain asbestos until proven otherwise.

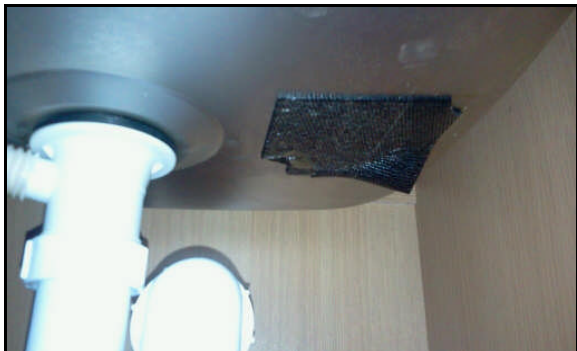
Building ID	Joint Valuation Board & Education Resource Centre	Item Description	Bitumen Sink Pad
Sample No.	S0085	Material	Bituminous Products
Floor	First Floor	Asbestos Type	No Asbestos Detected
Room No.	79	Extent	-
Room ID	Kitchen	Notes: No access was gained within the timber riser on walls 3 & 4 as access would have caused irreparable damage, therefore it is presumed to contain asbestos until proven otherwise.

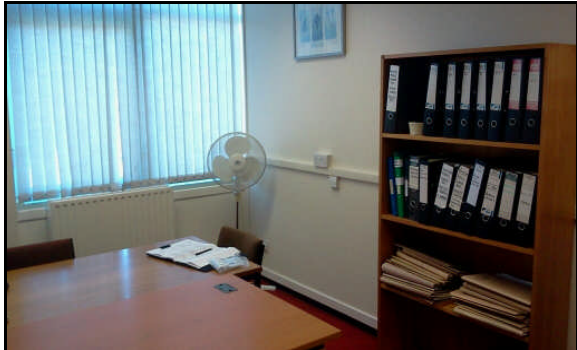
Building ID	Joint Valuation Board & Education Resource Centre	Item Description	No Suspect Materials Seen
Sample No.	-	Material	-
Floor	First Floor	Asbestos Type	-
Room No.	80	Extent	-
Room ID	Office	Notes: No access was gained below the fixed carpet due to the irreparable damage that would be caused, therefore it must be presumed to contain asbestos until proven otherwise.

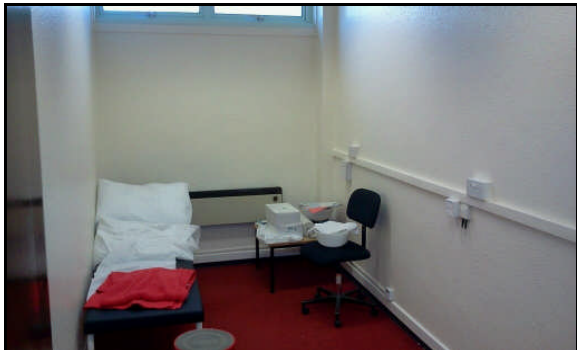
Building ID	Joint Valuation Board & Education Resource Centre	Item Description	No Suspect Materials Seen
Sample No.	-	Material	-
Floor	First Floor	Asbestos Type	-
Room No.	81	Extent	-
Room ID	First Aid Room	Notes: No access was gained below the fixed carpet due to the irreparable damage that would be caused, therefore it must be presumed to contain asbestos until proven otherwise. No access was gained to the ceiling void due to fixed ceiling tiles, therefore asbestos is presumed to be present until proven otherwise

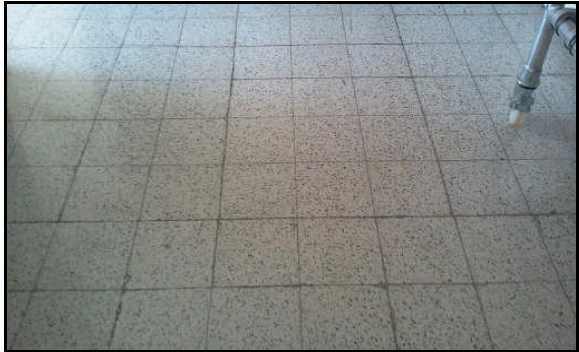
Building ID	Joint Valuation Board & Education Resource Centre	Item Description	Composite Flooring
Sample No.	As S0001	Material	Composite Flooring
Floor	First Floor	Asbestos Type	No Asbestos Detected
Room No.	82	Extent	-
Room ID	Landing	Notes: No access was gained within the ceiling void due to fixed ceiling tiles therefore asbestos must be presumed to be present until proven otherwise. No access was gained within the live electrics for safety reasons, therefore they are presumed to contain asbestos until proven otherwise. No access was gained within the timber riser as access would have caused irreparable damage, therefore it must be presumed to contain asbestos until proven otherwise.

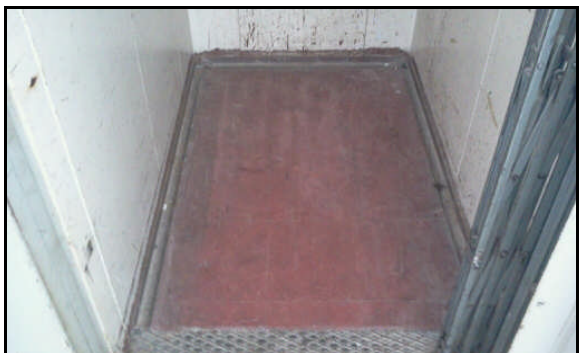
Building ID	Joint Valuation Board & Education Resource Centre	Item Description	Red Vinyl Floor Tiles
Sample No.	S0086	Material	Vinyl Product
Floor	First Floor	Asbestos Type	No Asbestos Detected
Room No.	83	Extent	-
Room ID	Lift Car	Notes:

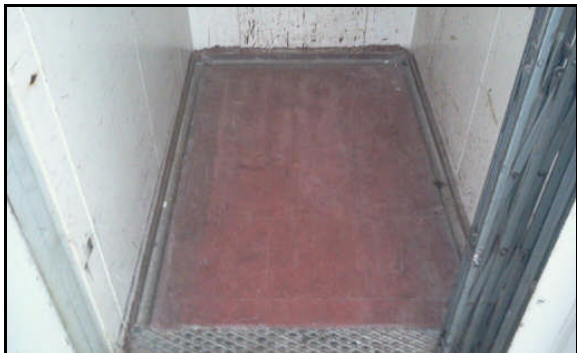
Building ID	Joint Valuation Board & Education Resource Centre	Item Description	Adhesive On Red Vinyl Floor Tiles
Sample No.	S0087	Material	Adhesive
Floor	First Floor	Asbestos Type	No Asbestos Detected
Room No.	83	Extent	-
Room ID	Lift Car	Notes:

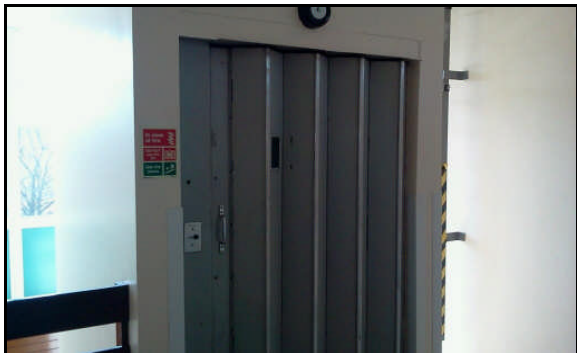
Building ID	Joint Valuation Board & Education Resource Centre	Item Description	No access was made to this location.
Sample No.	-	Material	-
Floor	First Floor	Asbestos Type	-
Room No.	84	Extent	-
Room ID	Lift Shaft	Notes:

This location was not accessed due to the potential health hazards involved and as such should be considered to contain asbestos until proven otherwise.	
		Surveyor: Donald Campbell	
		Recommendation: -

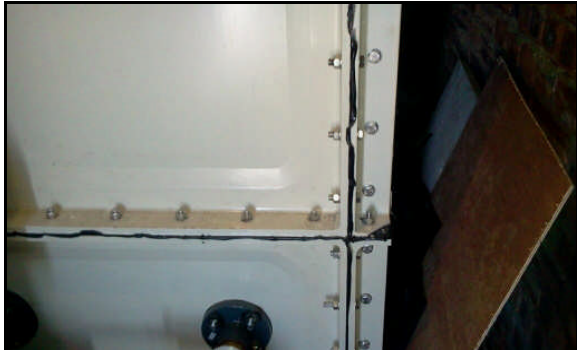
Building ID	Joint Valuation Board & Education Resource Centre	Item Description	Mastic Seal To Plastic Tank
Sample No.	S0092	Material	Mastics
Floor	First Floor	Asbestos Type	No Asbestos Detected
Room No.	85	Extent	-
Room ID	Tank Room	Notes: No access within live electrics & lift machinery, as access was unsafe, therefore presumed to contain asbestos until proven otherwise.

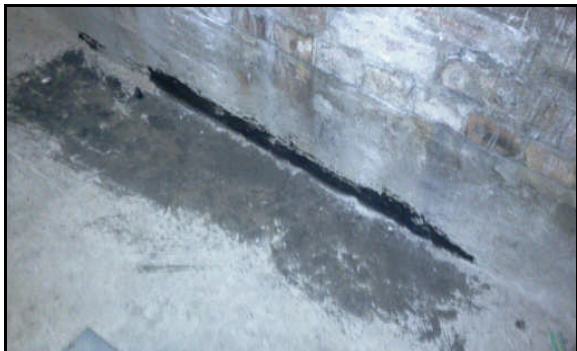
Building ID	Joint Valuation Board & Education Resource Centre	Item Description	Bitumen Damp Proof Course
Sample No.	S0093	Material	Bituminous Products
Floor	First Floor	Asbestos Type	No Asbestos Detected
Room No.	85	Extent	-
Room ID	Tank Room	Notes: No access within live electrics & lift machinery, as access was unsafe, therefore presumed to contain asbestos until proven otherwise.

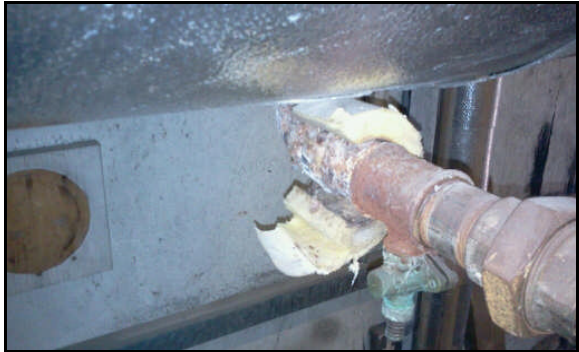
Building ID	Joint Valuation Board & Education Resource Centre	Item Description	Residue On Metal Pipes Below Calorifier
Sample No.	S0095	Material	Insulation
Floor	First Basement Level	Asbestos Type	No Asbestos Detected
Room No.	86	Extent	-
Room ID	Boiler Room	Notes: No access was gained within the gaskets to pipework, within the metal encased pipework, within the live electrics or within the redundant electric heaters for safety reasons. These must therefore be presumed to contain asbestos until proven otherwise. No access was gained within the concrete flue due to the irreparable damage that would be caused, therefore asbestos must be presumed to be present until proven otherwise.

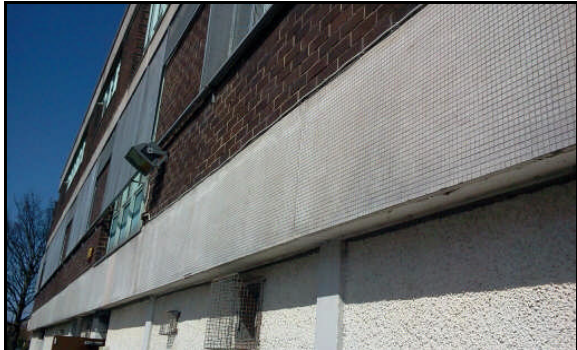
Building ID	Joint Valuation Board & Education Resource Centre	Item Description	Ceramic Tile Adhesive On Walls
Sample No.	S0088	Material	Adhesive
Floor	External	Asbestos Type	No Asbestos Detected
Room No.	EXT	Extent	-
Room ID	Elevations	Notes:

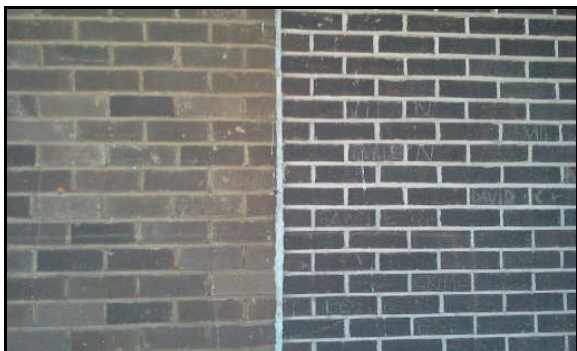
Building ID	Joint Valuation Board & Education Resource Centre	Item Description	Expansion Joint
Sample No.	S0089	Material	Mastics
Floor	External	Asbestos Type	No Asbestos Detected
Room No.	EXT	Extent	-
Room ID	Elevations	Notes:

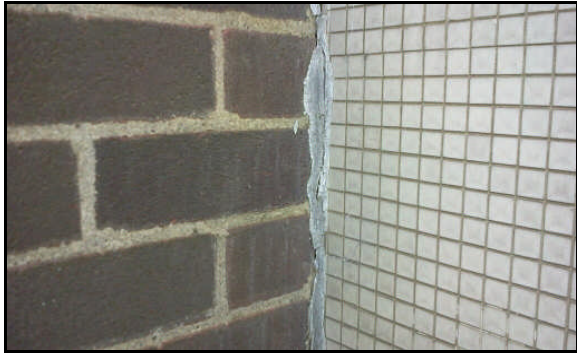
Building ID	Joint Valuation Board & Education Resource Centre	Item Description	Mastic Around Windows
Sample No.	S0090	Material	Mastics
Floor	External	Asbestos Type	No Asbestos Detected
Room No.	EXT	Extent	-
Room ID	Elevations	Notes:

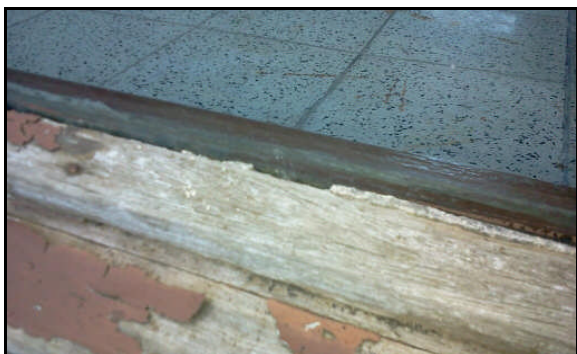
Building ID	Joint Valuation Board & Education Resource Centre	Item Description	Window Putty
Sample No.	S0091	Material	Putty
Floor	External	Asbestos Type	No Asbestos Detected
Room No.	EXT	Extent	-
Room ID	Elevations	Notes:

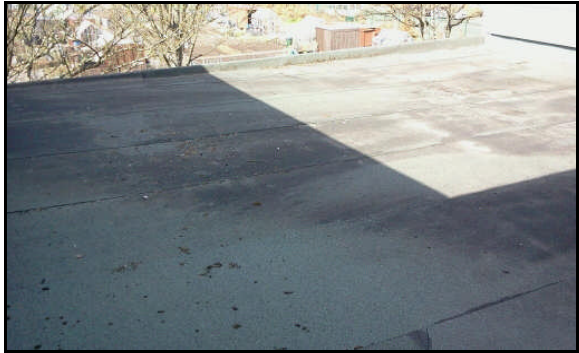
Building ID	Joint Valuation Board & Education Resource Centre	Item Description	No access was made to this location.
Sample No.		Material	
Floor	External	Asbestos Type	
Room No.	EXT	Extent	
Room ID	Flat Roof Areas	Notes:	This location was not accessed due to height restrictions and as such should be considered to contain asbestos until proven otherwise.

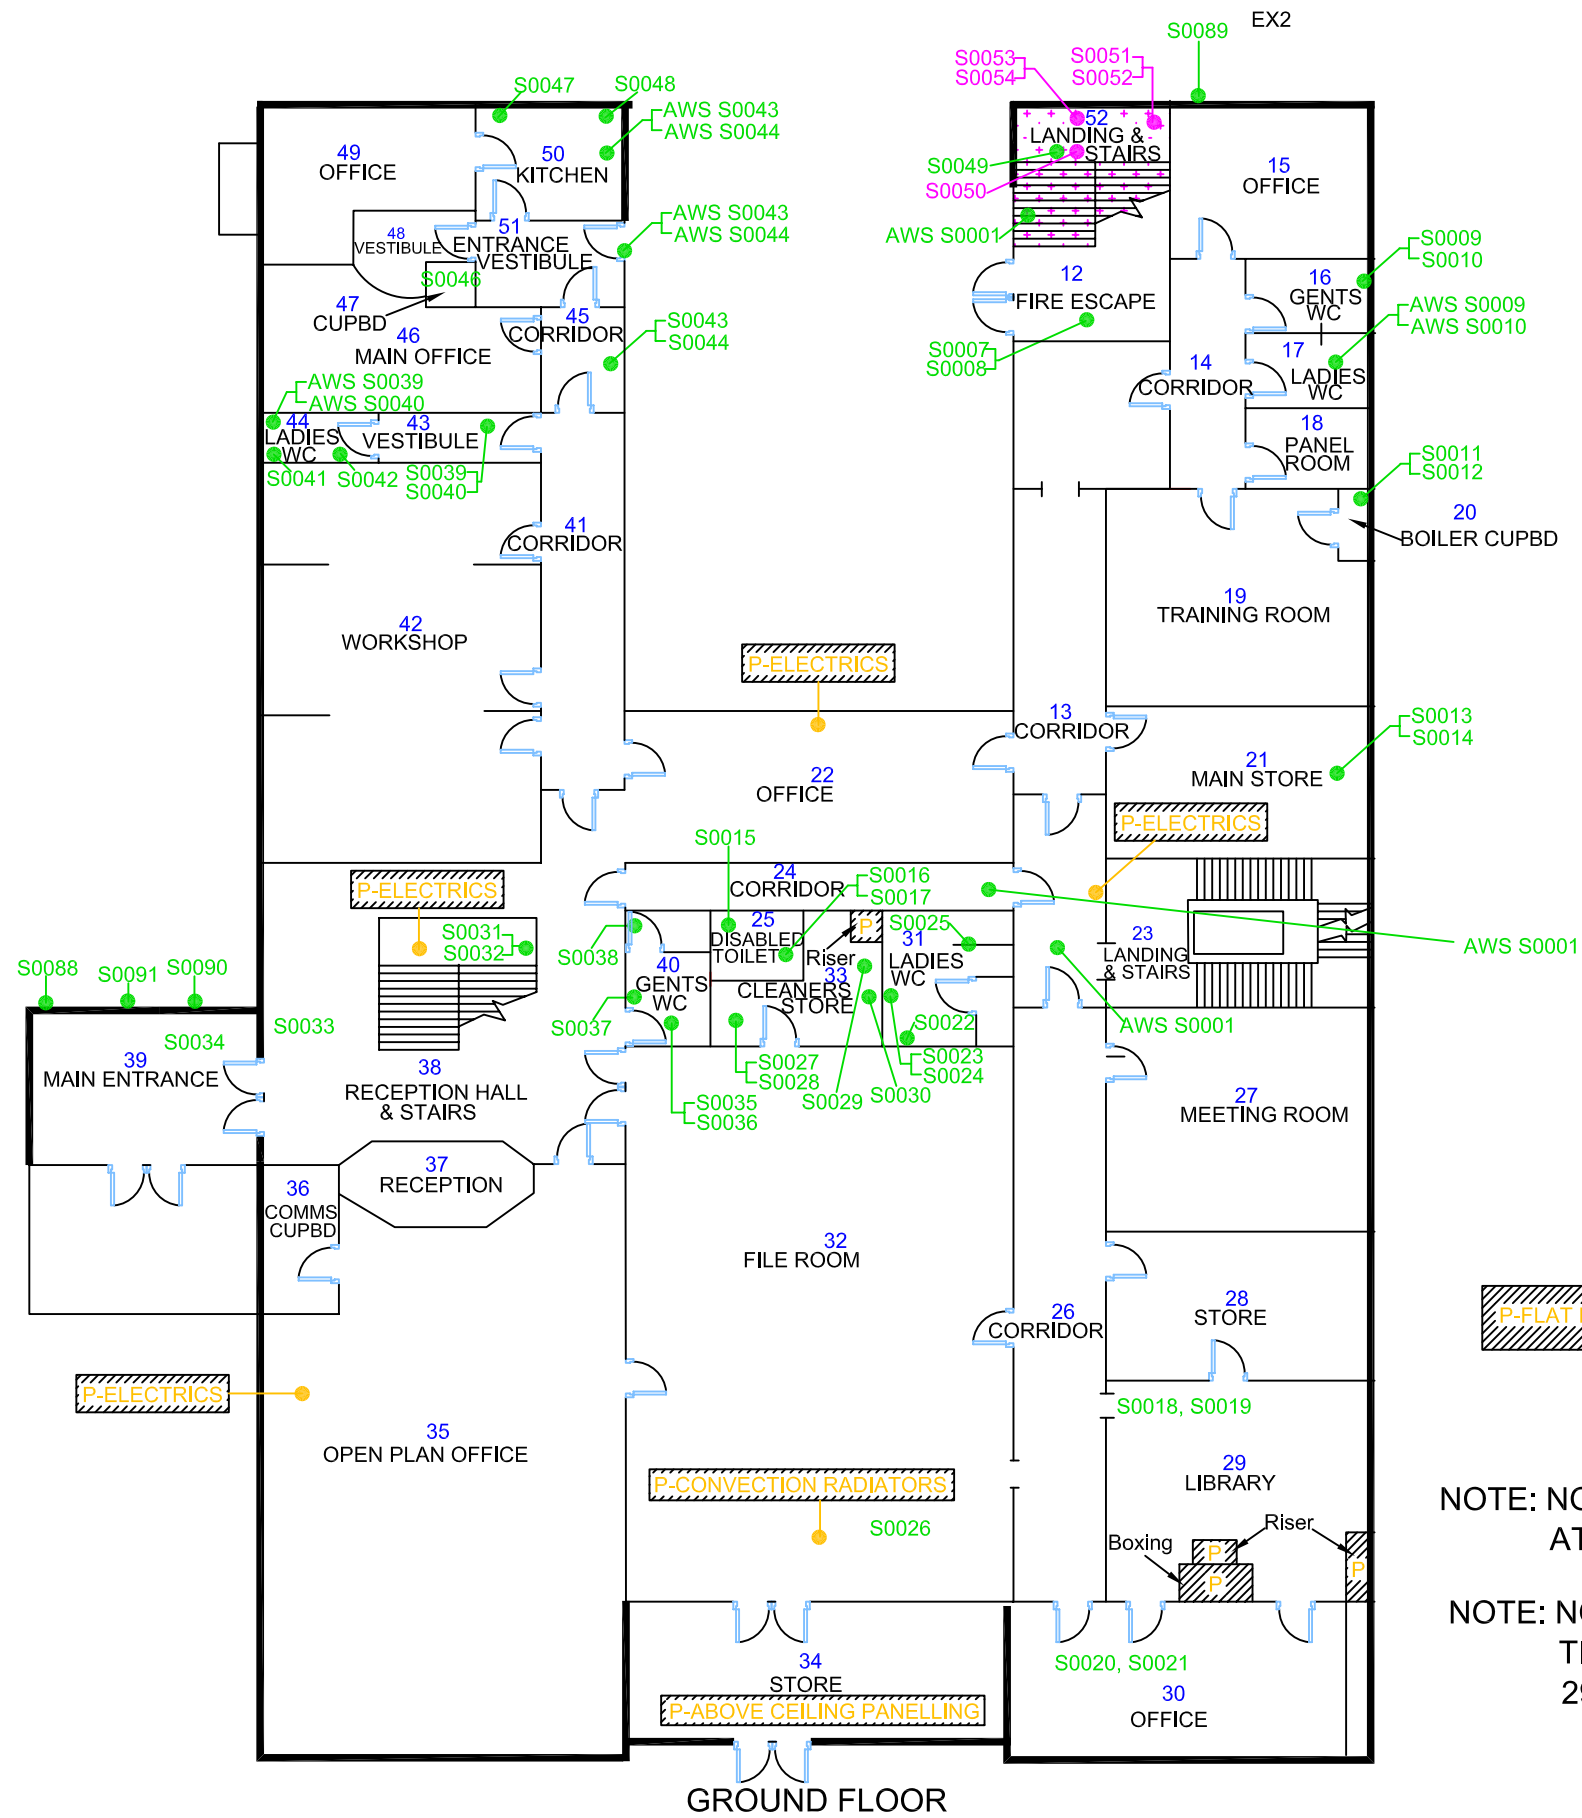
NOTE: NO ACCESS WAS GAINED BELOW THE FIXED CARPET AT LOCS 18, 19, 22, 32, 38, 41, 42, 46, 48, 49

NOTE: NO ACCESS WAS GAINED ABOVE FIXED CEILING TILES AT LOCS 12, 13, 14, 15, 19, 21, 24, 26, 27, 28, 29, 30, 32, 34, 45, 48, 49, 52
