Asbestos Management Survey
At
**Joint Valuation Board and Education Resource Centre,
235 Dumbarton Road, Clydebank**

Customer: West Dunbartonshire Council

Project No: G13-00301

Report Issue Date: 14 June 2013

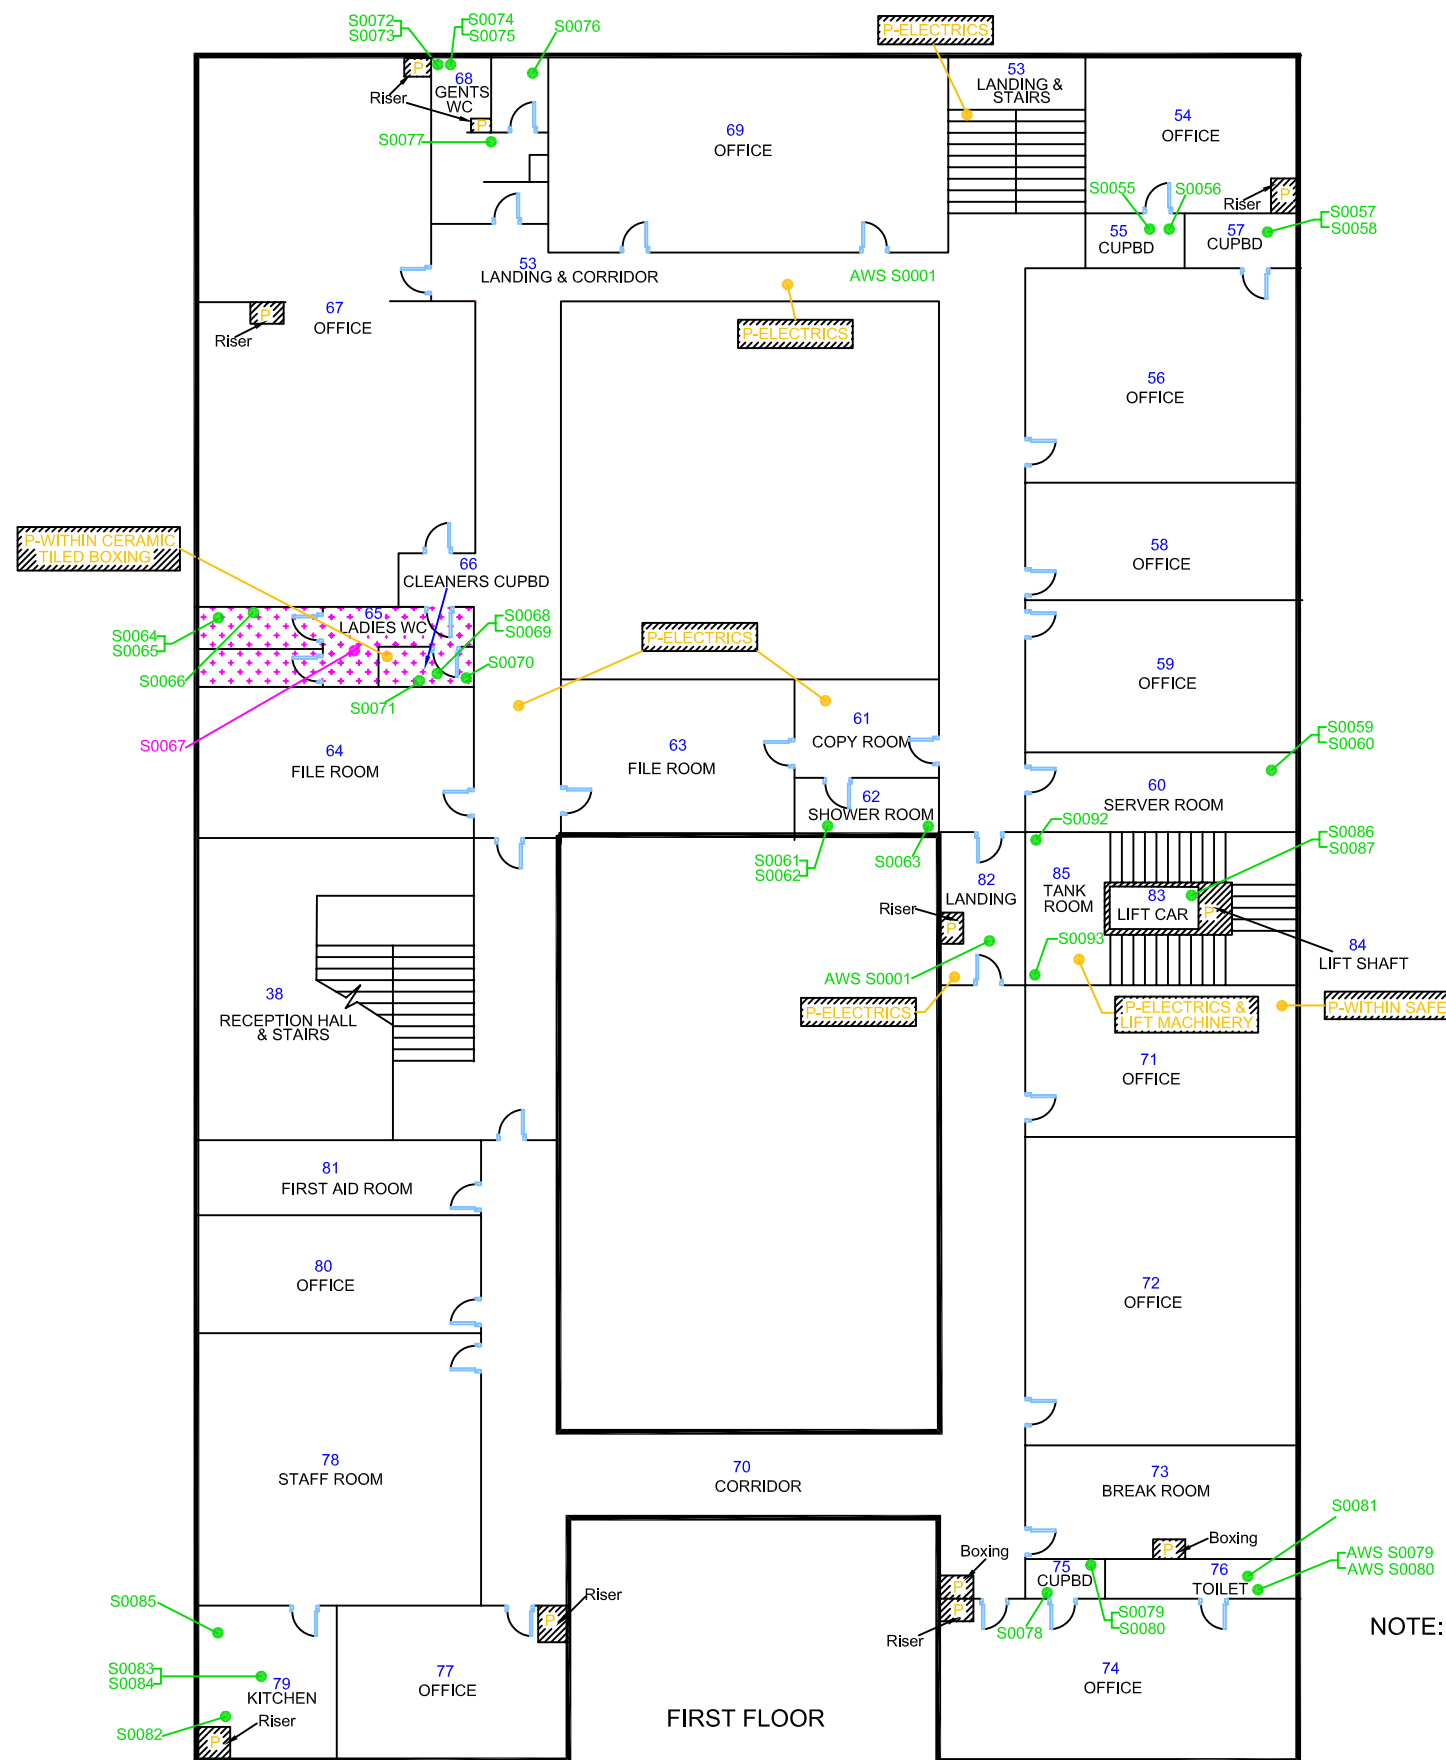
NOTE: NO ACCESS WAS GAINED BELOW THE FIXED CARPET AT LOCS 53, 54, 56, 58, 59, 61, 63, 64, 67, 69, 70, 71, 72, 73, 74, 77, 78, 80, 81

NO ACCESS WAS GAINED ABOVE FIXED CEILING TILES AT LOCS 53, 54, 58-62, 64, 67, 69-74, 77, 81
